**HYUNDAI**
Technical Service Bulletin

GROUP RECALL	NUMBER 24-01-024H
DATE MARCH 2024	MODEL(S) IONIQ 5 (NE1) IONIQ 6 (CE1)

SUBJECT: INNER SHAFT REPLACEMENT
(RECALL 253)

Description: Certain 2023MY IONIQ 5 (NE1) and IONIQ 6 (CE1) may contain rear inner shafts that could fracture due to improper heat treatment. A fractured inner shaft may result in a loss of motive power while driving, increasing the risk of injury in a crash or impact. Follow the procedures in this TSB to replace the inner shaft.

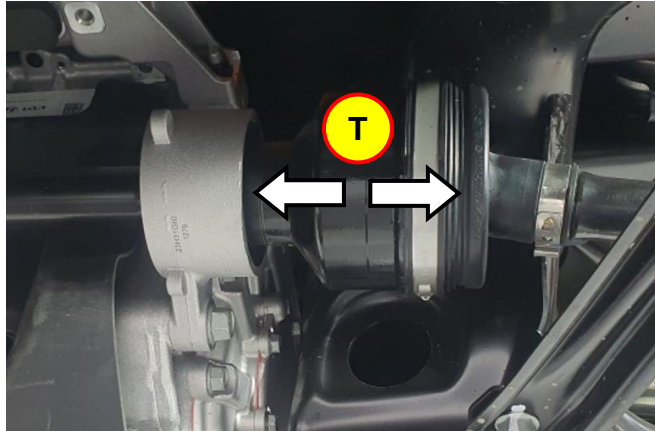
The IDA joint cup (T) should not slide back and forth on the inner shaft. The inner shaft circlip should securely retain the IDA joint cup.

GOOD: IDA dust cover (R) is fully inserted into the inner shaft bracket (S).

18. After installing the new inner shaft, ensure that the IDA is properly installed.
