## Technical Service Bulletin

<b>GROUP</b>	<b>NUMBER</b>
<b>RECALL</b>	<b>24-01-024G</b>
<b>DATE</b>	<b>MODEL(S)</b>
<b>MARCH 2024</b>	<b>GV60 (JW1 EV)</b>

**SUBJECT:** INNER SHAFT REPLACEMENT  
(RECALL 017G)

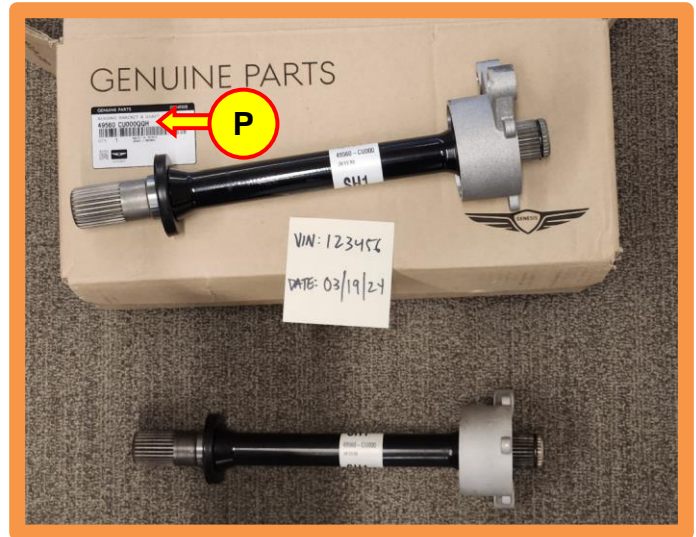
Using STUI, take a photo of the new QQH inner shaft on the parts box with the part number (P) clearly visible, the original removed inner shaft next to the box, and the last 6 digits of the VIN and the date of repair on a piece of paper.

Upload the photo to STUI.
