GROUP	MODEL
Safety Recall Campaign	2024MY Telluride (ON)
NUMBER	DATE
SC296 (Rev 1, 08/08/2024)	March 2024

Subject: **ENGINE SUB-ASSEMBLY REPLACEMENT (SC296)**

This bulletin provides information to replace the engine sub-assembly on certain 2024MY Telluride (ON) vehicles produced from October 1, 2023 through December 6, 2023. The engine valve springs in the subject vehicles may break while driving due to fatigue cracking as a result of damage to the springs during manufacture by the supplier. A broken valve spring may result in a loss of motive power. In rare cases, a hole in the engine block may occur due to a broken valve entering the combustion chamber. A loss of motive power increases the risk of crash. A hole in the engine block increases the risk of a fire. Customers may experience abnormal engine noise, check engine light illumination, and engine running rough. Follow the procedure outlined in this publication to replace the engine sub-assembly on the applicable vehicle. Before conducting the procedure, verify that the vehicle is included in the list of affected VINs.

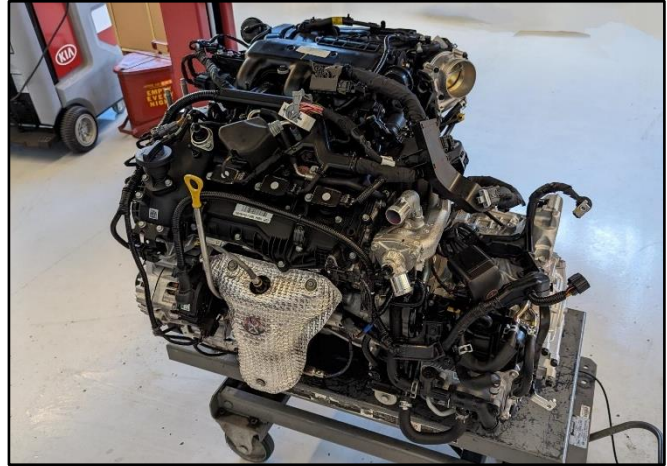
Note: Front drive axles (**FWD & AWD**) at brake rotors and the three (3) rear propeller shaft mounting bolts (**AWD only**) were not removed.

1. Remove the engine sub-assembly by referring to “Engine Mechanical System → Engine and Transaxle Assembly → Engine and Transaxle Assembly → Removal and Installation” in the applicable Shop Manual on KGIS.

- Clean the HF EOP connector using shop air to remove any oil, coolant, and/or debris.
- Cover the connector using non-residue tape or plastic covering.
- Confirm the HR EOP remains covered during automatic transmission installation until the harness is connected.
