SAFETY RELATED RECALL

Global Recall Action
Number: H468v3

Subject: High Voltage (HV) Battery Busbar Fixings	Publication No.: H468v3
	Model: I-PACE (X590)
	Model Year: 2019 - 2021
	Date of Issue: 29 April 2024

SERVICE INSTRUCTION - H468V3

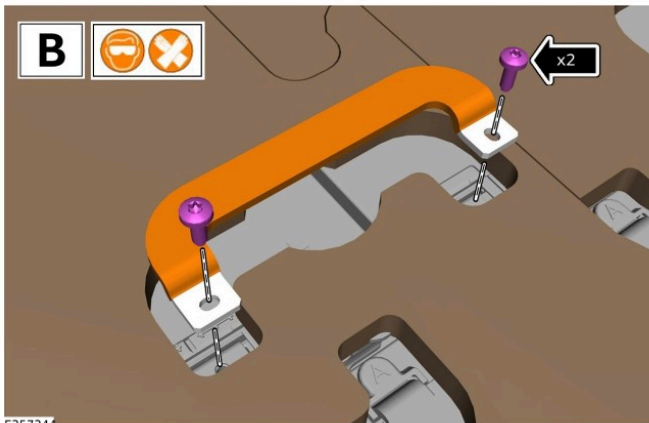
E357344

- Make a note of all damage found and the installed position of the damaged busbar within the [H.V.](#) battery.
- All findings **must** be reported to [T.A.](#)
- The images marked with a **RED 'X'** show an example of busbar damage caused by overheating, make a note of all damage found.

- Clean the busbar contact areas (**A**) with alcohol based cleaning fluid and a lint free cloth.
- Visually inspect the contact areas (**A**) for signs of damage.
- Visually inspect the protective insulation for damage (**B**).
- If there **ARE** any signs of damage as shown in the images marked with a **RED 'X'**, make a note of the installed position of the busbar in the [H.V.](#) battery. **Continue to step 18, do not reinstall the busbars.**
- If there **ARE NOT** any signs of damage, **continue to step 18, do not reinstall the busbars.**
