# SAFETY RELATED RECALL

Global Recall Action  
Number: H468v2

<b>Subject:</b>  <b>High Voltage (HV) Battery Busbar Fixings</b>	Publication No.: H468v2
	Model: I-PACE (X590)
	Model Year: 2019 - 2021
	Date of Issue: 22 April 2024

# SERVICE INSTRUCTION - H468V2

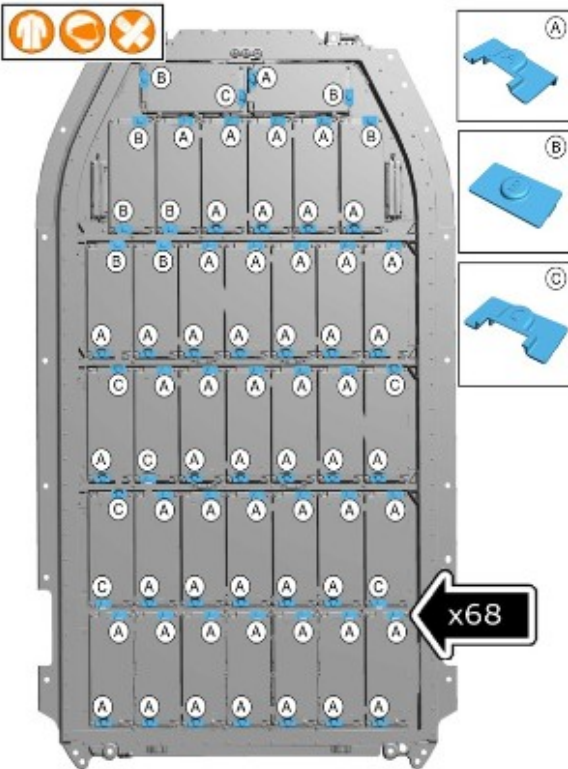
E359038

- Make a note of the installed position of the busbar caps, there are 3 types of caps as shown in the illustration.
- Care **must** be taken not to damage the busbar caps.

Remove the 68 busbar caps.
