SIB 34 02 24

RECALL 24V-104: INTEGRATED BRAKING SYSTEM

This Service Information Bulletin (Revision 2) replaces SI B34 02 24 **dated August 2024**.

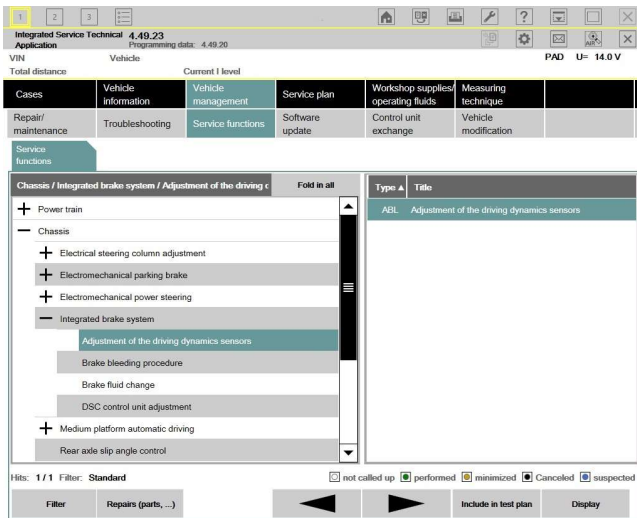
Yes, Submit TSARA case, subject line: B34 02 24 Blue dot and await further assistance.

Refer to the Note in Step 4 for additional clarification on the blue dot.
