SIB 34 02 24

**RECALL 24V-104: INTEGRATED BRAKING SYSTEM**

This Service Information Bulletin (Revision 4) replaces SI B34 02 24 **dated September 2024**.

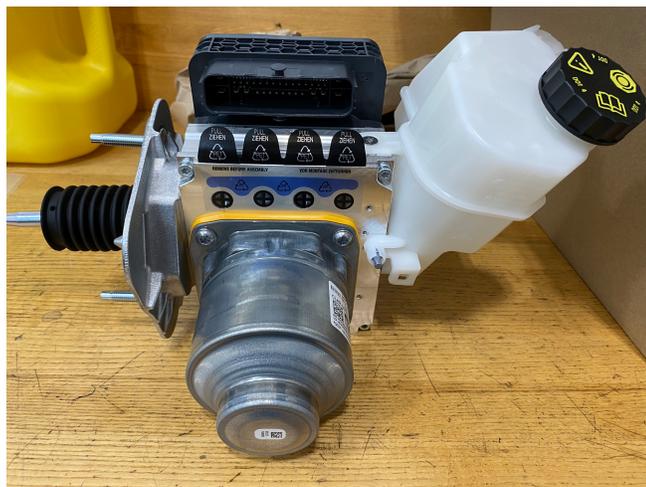
**“Wet” IB pre-filled:** Brake fluid reservoir is filled (arrow) and brake fluid line ports are plugged with bolts (circled).

Replace the IB with either a “wet” pre-filled unit or a “dry” unfilled unit.

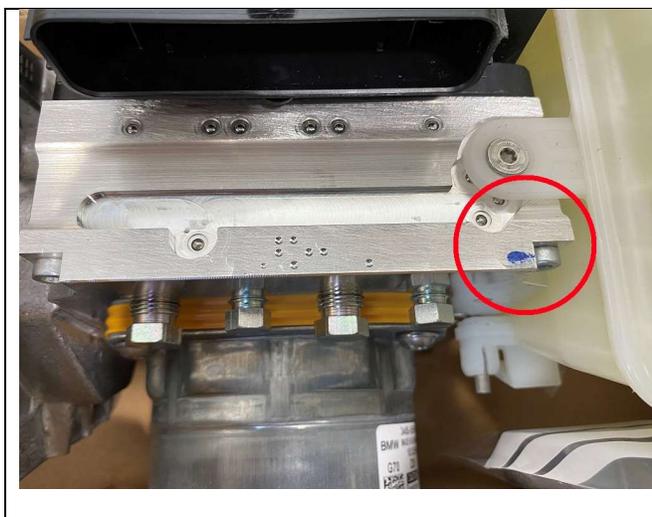
**Note:** Photo shown for location of blue dot on the parts label and does not indicate the part number for all models

6. Verify the blue dot is located on the part number label as shown in the photo.

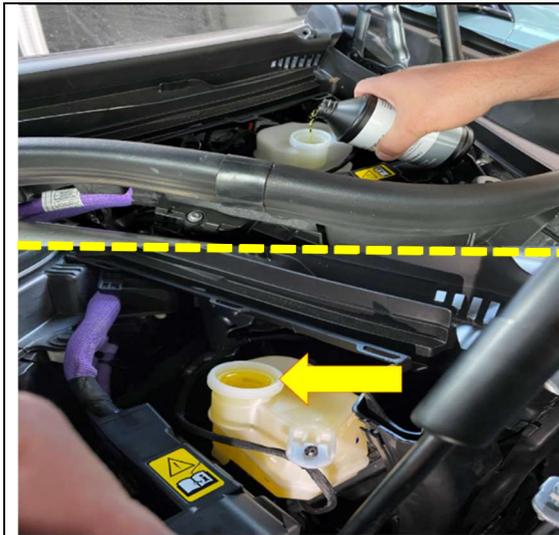
- **Note:** When removing the brake pedal, be particularly careful as not to damage the retaining lugs on the holding clip
- **Hint:** Prior to installing the IB, inspect the brake line ports for damaged threads.
- **Note:** the wheel circuit connections must be properly torqued and inspected for leaks as per the repair instructions

11. Replace the IB as per modified REP 34 51 601, Hydraulic unit replacement.

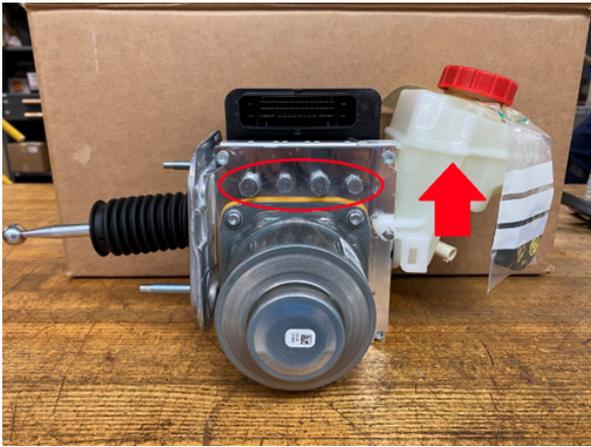
**“Wet” IB pre-filled:** Brake fluid reservoir is filled (arrow) and brake fluid line ports are plugged with bolts (circled)

Replace the IB with either a “wet” pre-filled unit or a “dry” unfilled unit.

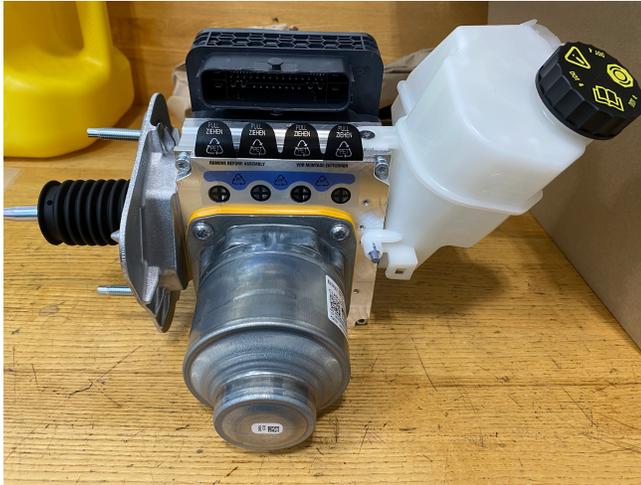
**“Dry” IB unfilled:** Brake fluid reservoir is empty; brake fluid line ports are sealed with labels.

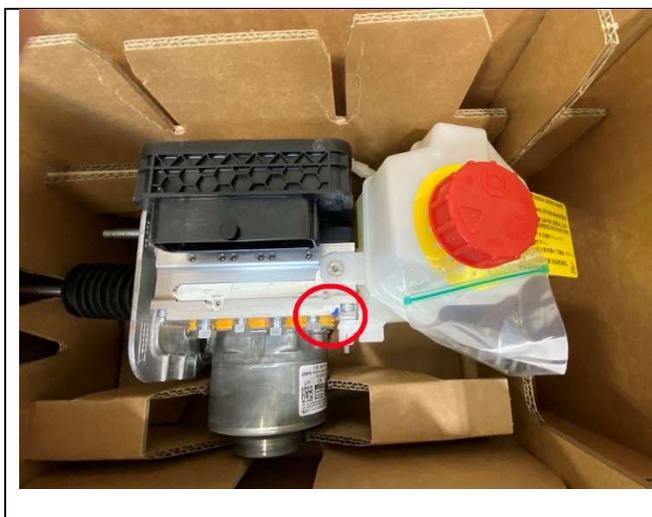
6. Verify the blue dot is located on the part number label as shown in the photo.

**Note:** Photo shown for location of blue dot on the parts label and does not indicate the part number for all models

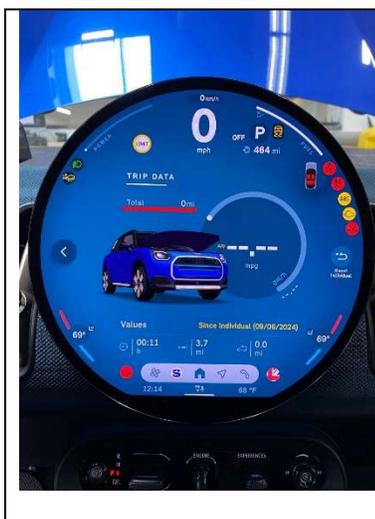
**WARNING: For U10 and U11 vehicles do not proceed with programming of the vehicle if this warning message appears. Contact technical service via TSARA for further instructions.**

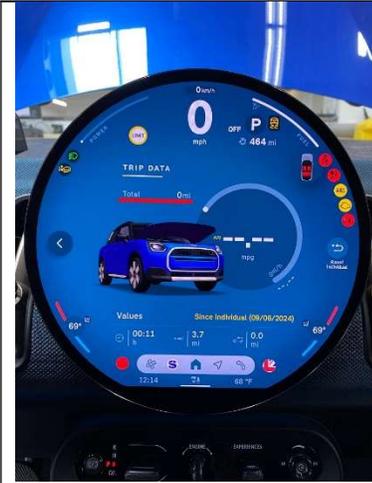
**WARNING: For U10 and U11 vehicles do not proceed with programming of the vehicle if this warning message appears. Contact technical service via TSARA for further instructions.**
