SIM 34 01 24

2025-07-17

RECALL 24V-104: INTEGRATED BRAKING SYSTEM (IB)

This Service Information Bulletin (Revision 12) replaces SI M34 01 24 **dated May 2025**.

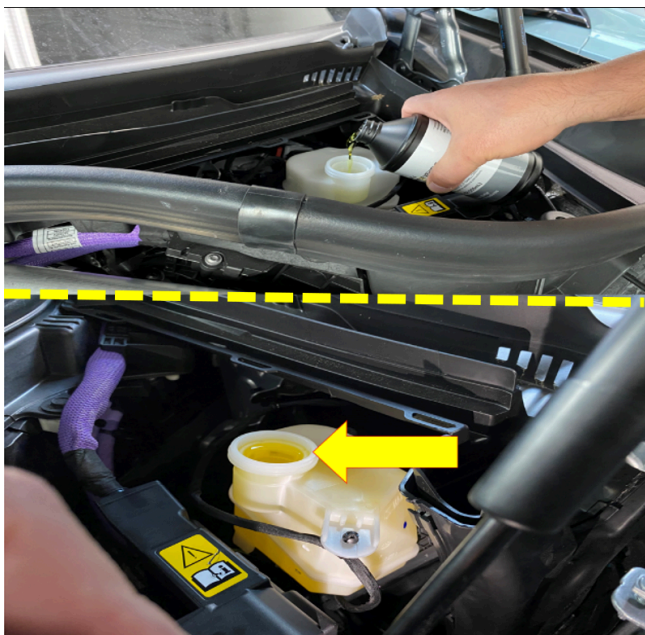
If you have received a “wet” unit, follow the REP34 51 601 Replacing hydraulic unit

If you have received a “dry” unit, follow the REP 34 51 602 Replacing the hydraulic unit (not filled).

Important:
Prior to connecting the negative battery cable as per the REP instructions follow up works step 23, manually fill the brake fluid reservoir to just below the rim of the filler, above the “MAX” mark. Reinstall the fluid reservoir cap and continue REP procedures

Failure to fill prior to battery connection may result in extended or additional bleeding procedures

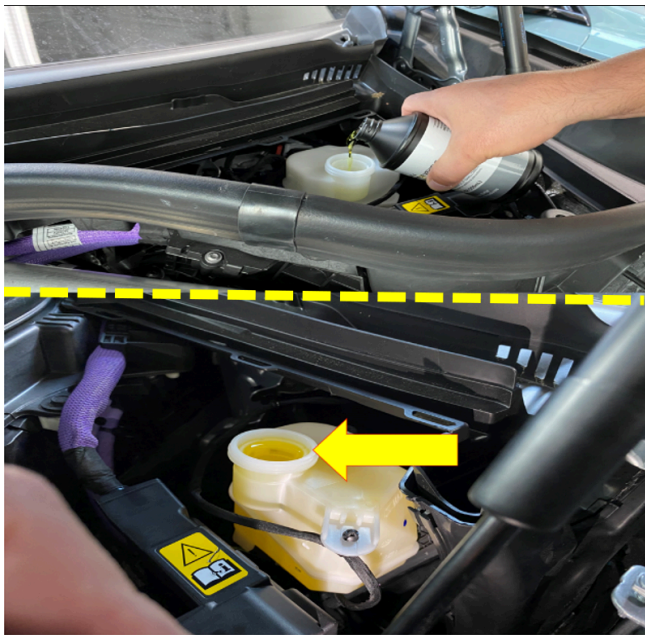
Do not install any part which shows visual damage as shown, or has been dropped from any height.

If you have received a “**wet**” unit, follow the REP34 51 601 Replacing hydraulic unit

If you have received a “dry” unit, follow the REP 34 51 602 Replacing the hydraulic unit (not filled).
