Subject: **Update - BMW Integrated Brake Recall - Software Now Available**

SIB 34 02 24

RECALL 24V-104: INTEGRATED BRAKING SYSTEM

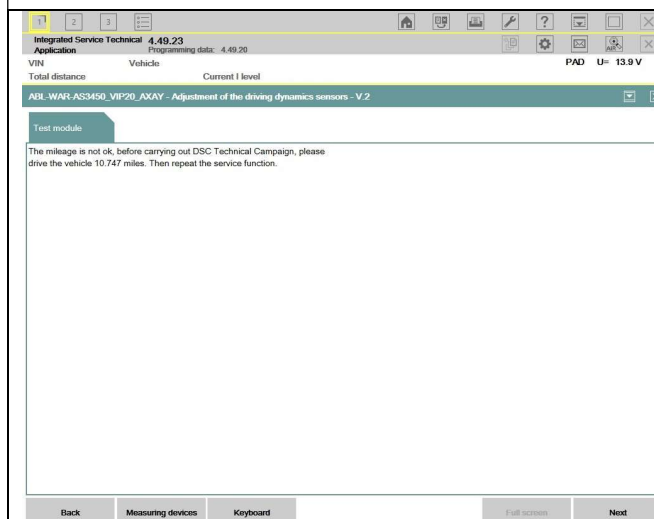
## 3. With vehicle connection established, select Vehicle Management and Service Functions

- Select Chassis/Integrated brake system/Persistent odometer reading.
- Select the ABL, Display persistent odometer reading, then select display to run the test plan
- In the service function test plan select "persistent odometer reading" DSC Technical Campaign

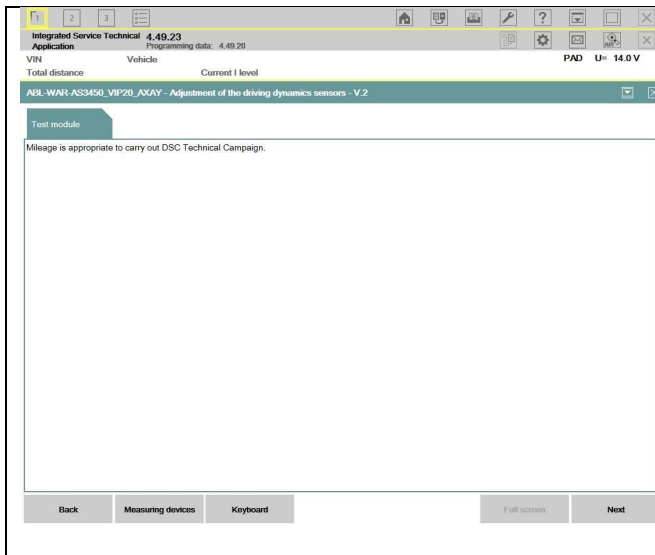
- The test plan results will determine whether the vehicle needs to be driven x number of miles, as shown in the photo, or the mileage is appropriate to proceed with IB replacement.
- Note:** The vehicle must be driven the minimum given miles but not beyond 0.5 miles above. Anything above or below will result in another required drive.

**Note:** the photo shown is only an example of a vehicle test which requires miles accrued before replacing an IB

- Repeat the service function after the vehicle has been driven the given number of miles from the test plan results.

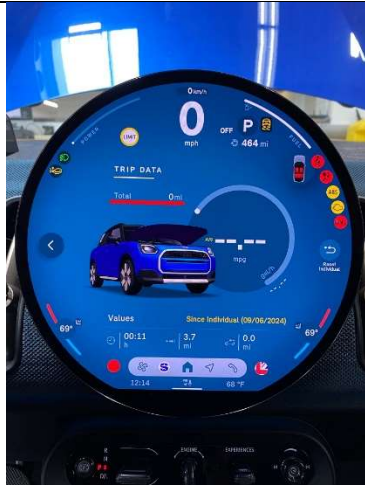
**WARNING: For U25 vehicles do not proceed with programming of the vehicle if this warning message appears. Contact technical service via TSARA for further instructions.**
