SIB 34 04 23

## RECALL 24V-104: INTEGRATED BRAKE SYSTEM (IB)

This Service Information Bulletin (Revision 7) replaces SI B34 04 23 **dated May 2024**.

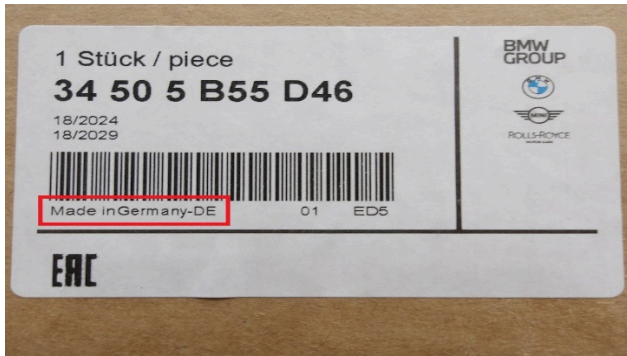
Prior to removing an IB from the vehicle, an inspection process of the new part must be performed

Determine the country of manufacturer of the component. If made in the USA proceed with the installation.

The following process only applies to service parts from production “Made in Germany DE” as shown in the red box on the parts label.
