## SIB 34 02 24

### RECALL 24V-104: INTEGRATED BRAKING SYSTEM

2026-01-09

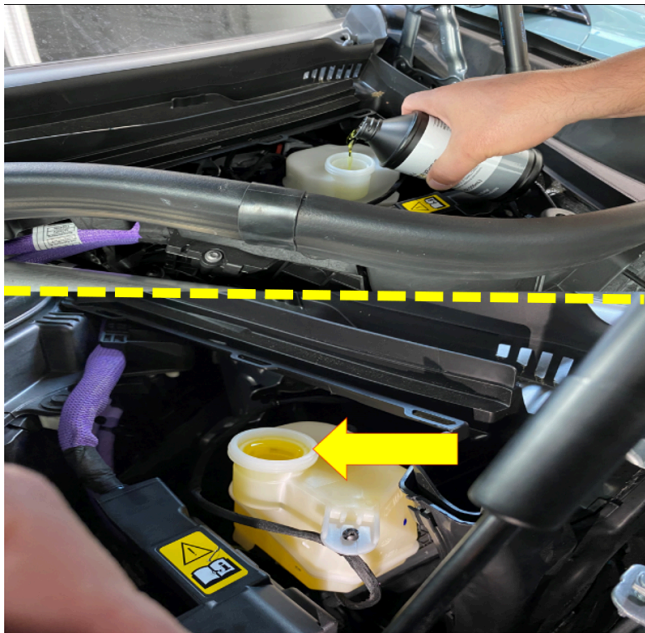
Do not install any part which shows visual damage as shown, or has been dropped from any height.

If you have received a “**wet**” unit, follow the REP34 51 601 Replacing hydraulic unit

If you have received a “**dry**” unit, follow the REP 34 51 602 Replacing the hydraulic unit (not filled).

**Important:**  
**Prior to connecting the negative battery cable as per the REP instructions follow up works step 23, manually fill the brake fluid reservoir to just below the rim of the filler, above the “MAX” mark.**  
**Reinstall the fluid reservoir cap and continue REP procedures**
