Safety Recall Code: 20UF

Suction Jet Pump

The suction jet pump inside the fuel tank is designed to purge fuel from the Evaporative Emissions (EVAP) system. If a specific seal inside an affected suction jet pump fails, the fuel may flow directly into the EVAP system. If this happens, fuel could accumulate in the EVAP system and may leak through the charcoal canister filter element. Leaking fuel, in the presence of an ignition source, may result in a fire.

Replace the suction jet pump.

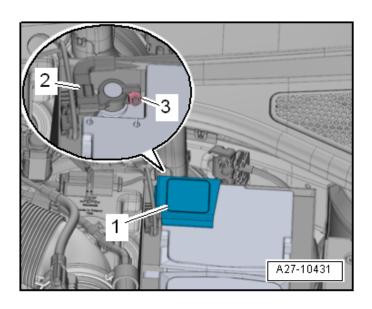
Disconnect the 12V battery:

- Move the front seats all the way forward.
- On vehicles equipped with power seats, be sure to move the front seats all the way forward before disconnecting the battery in the next step.
- Open the battery heat protection sleeve cover to access the cover <1> on the battery ground terminal <2>.
- Loosen the nut <3> several turns and remove the battery ground terminal <2> from the negative battery post and isolate the terminal.

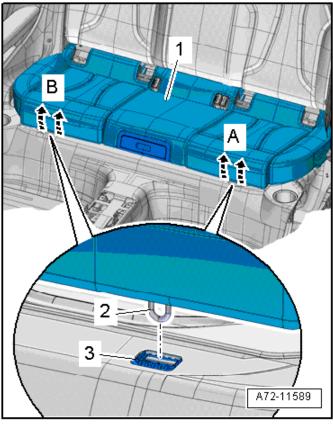
Remove the rear bench seat:

See ELSA Repair Manual: Repair Manual > Body > Body Interior > 72 Seat Frames > Rear Seats > Bench Seat/Single Seat, Removing and Installing

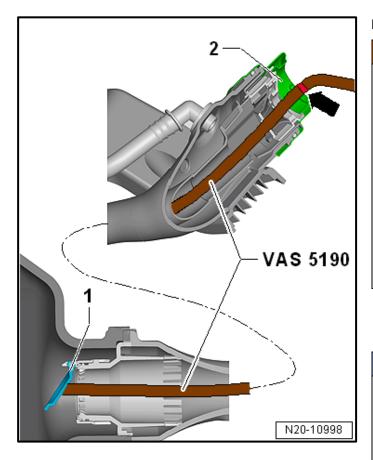
Drain the fuel tank:

- It is imperative that the exact amount of fuel removed from the fuel tank is reinstalled into the fuel tank at the end of this operation.
- Failing to reinstall the same of amount of fuel that was extracted can result in fuel level sending unit faults, or fuel gauge inaccuracies.
- Additional diagnostic time required to perform a capacitive discharge or remove fused power to the instrument cluster to clear these faults or inaccuracies are NOT covered under this campaign.
- See ELSA Repair Manual: Repair manual > Engine > Fuel Supply - Gasoline Engines > 20 Fuel Supply > Fuel Tank > Fuel Tank, Draining

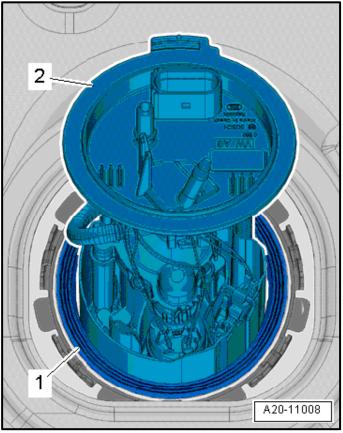
Remove the fuel delivery unit:

See ELSA Repair Manual: Repair manual > Engine > Fuel Supply - Gasoline Engines > 20 Fuel Supply > Fuel Delivery Unit/Fuel Level Sensor > Fuel Delivery Unit/Fuel Level Sensor, Removing and Installing,

During removal of the fuel delivery unit, it is very easy to damage the fuel level sensor. Use caution when removing the fuel delivery unit. Damage to the fuel level sensor is not covered under this action.
