TECHNICAL INSTRUCTIONS

24TA02

Vehicle May Move While In Neutral Position

**2022 - 2024 TUNDRA / TUNDRA HV
2023 AND 2024 SEQUOIA HV**

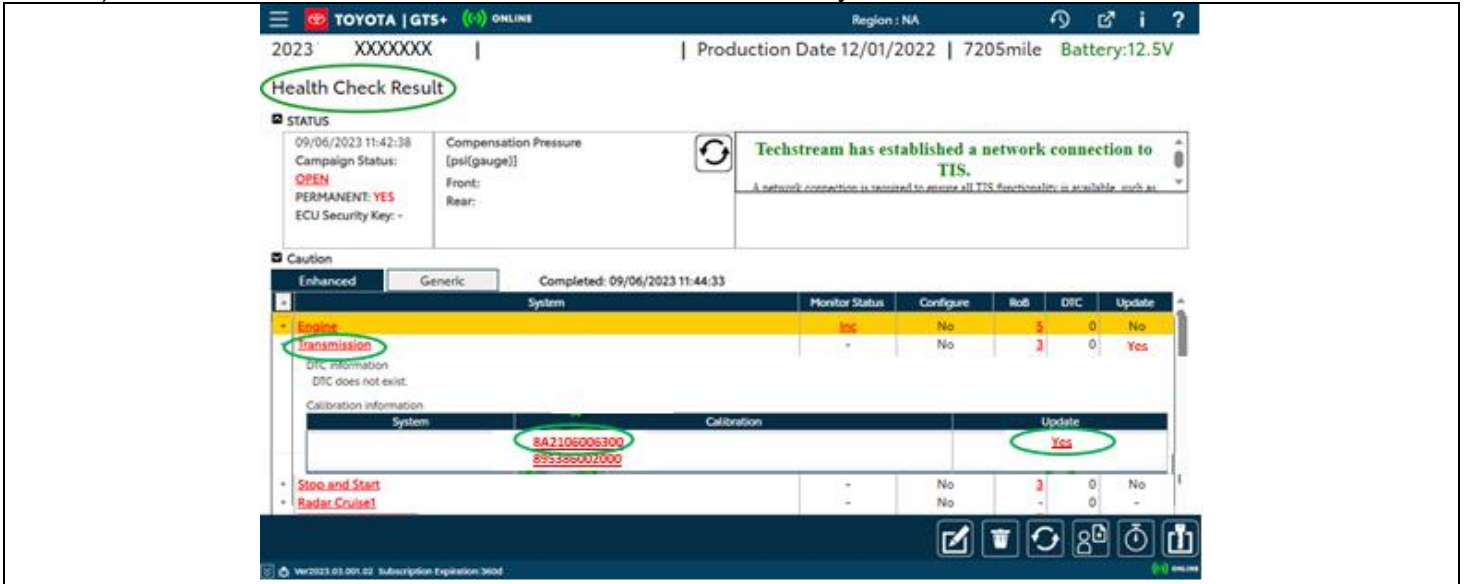
) Confirm the current calibration ID in the Transmission System.

The calibration IDs to re-flash in this campaign are as shown in the table below.
