Safety Recall Campaign

SC299

2020MY
Telluride (ON)
w/Halogen Headlamps

HALOGEN HEADLAMP (HIGH BEAM) ASSEMBLY
INSPECTION & REPAIR/REPLACEMENT (SC299)

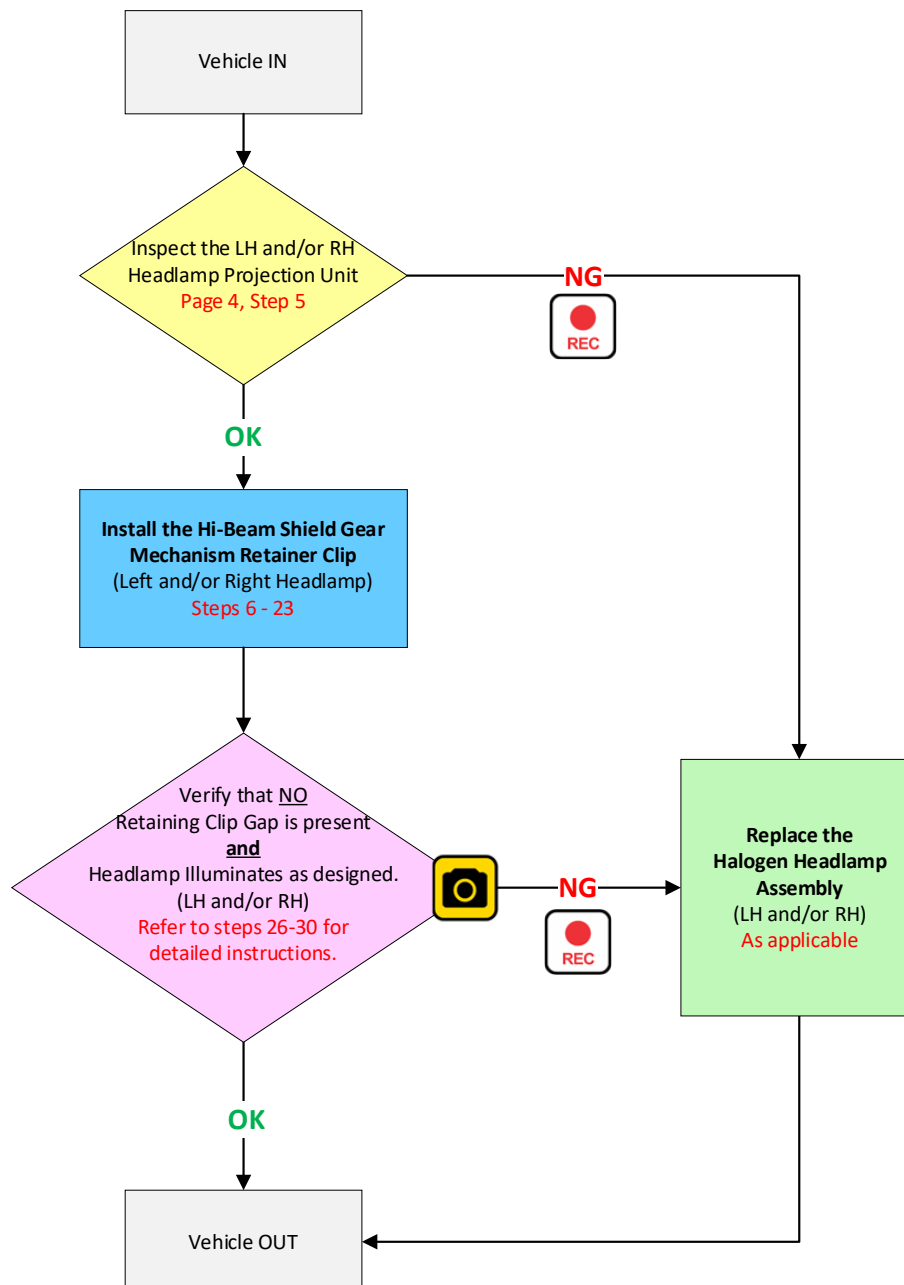
BEFORE BEGINNING: The repair and replacement are determined by carefully following the instructions outlined in this publication. Inspect the headlamp(s) per the applicable VIN (SC299B, SC299L or SC299R), and repair/replace either LH and/or RH side headlamps(s) by following the flowchart below:

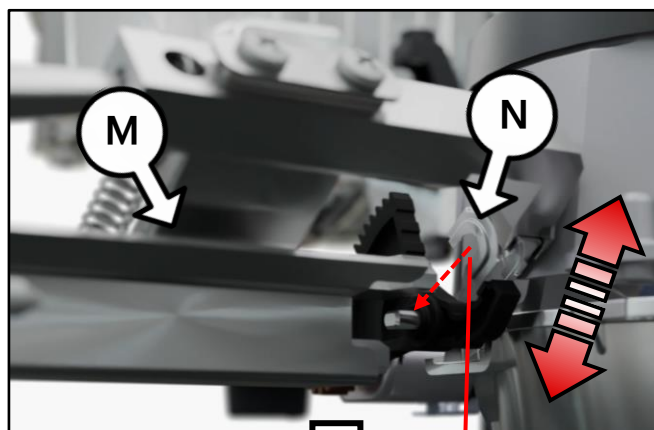
Note: The new gear retaining clip is designed to attach/snap onto the gear mechanism shaft to help secure it in place.

22. Ensure that the clip insertion tool (M) is completely inserted and resting down as shown (open).

Note: DO NOT attempt to close the clip insertion tool (M) until the gear retaining clip is evenly aligned and resting down.
