Safety Recall Campaign

SC299 (Rev 1, 09/30/2024)

2020MY
Telluride (ON)
w/Halogen Headlamp

HALOGEN HEADLAMP (HIGH BEAM) ASSEMBLY
INSPECTION & REPAIR/REPLACEMENT (SC299)

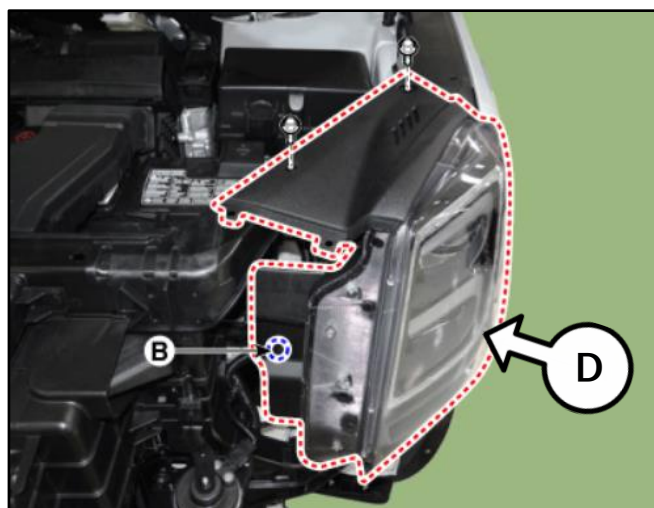
2. Remove the applicable (LH and/or RH) headlamp assembly (D) by referring to "Body Electrical System → Lighting System → Headlamp → Repair procedures" in the applicable Shop Manual on KGIS.

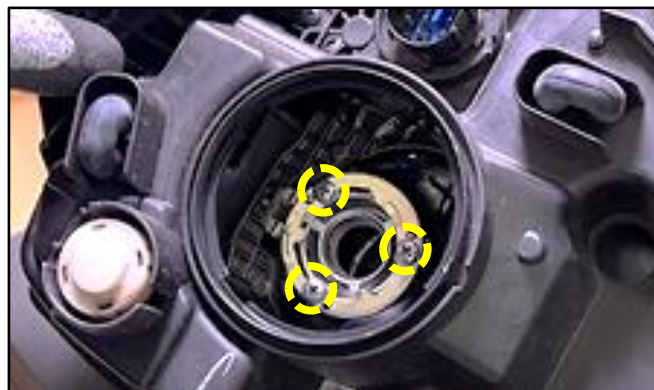
7. Loosen two (2) of the three projection unit screws in the pattern shown.

Note: DO NOT remove a 3rd screw. Refer to the patterns shown on the right.

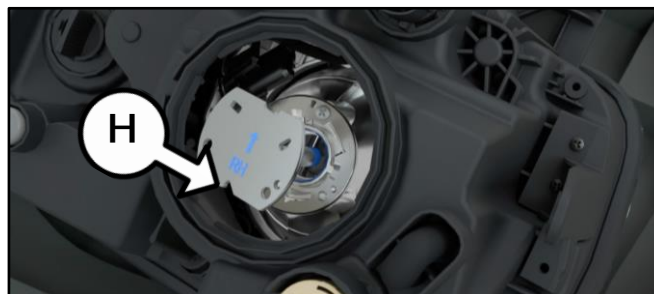
8. Carefully insert the applicable (LH or RH) shield fixing jig (H), as shown.

Note: The arrow on the shield fixing jig MUST face inwards, towards the inside of the headlamp.

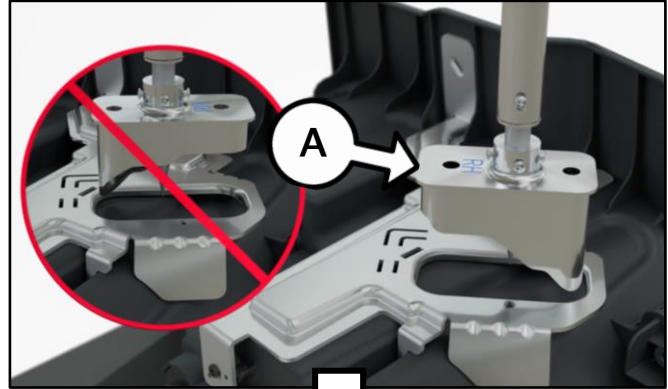
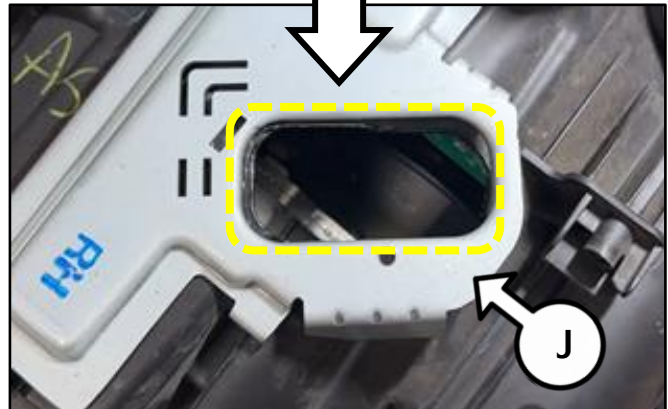
11. Using the pre-heated soldering iron, align the attached iron connecting tip (A) through the hole processing jig (J) opening.
12. Using medium/even downward pressure, burn through the headlamp outer case to create an access hole, as shown.

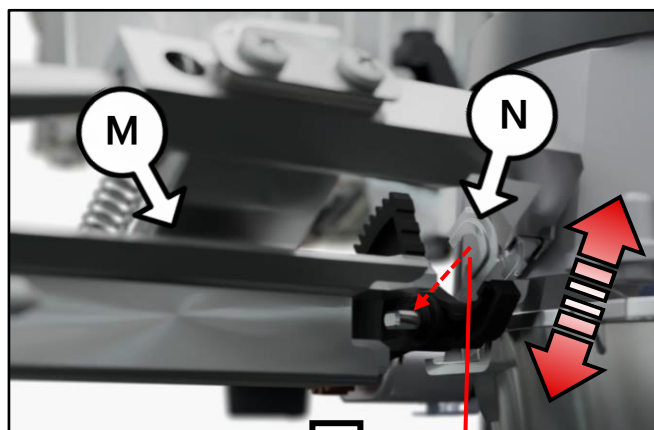
22. Ensure that the clip insertion tool (M) is completely inserted and resting down as shown (open).

Note: The new gear retaining clip is designed to attach/snap onto the gear mechanism shaft to help secure it in place.

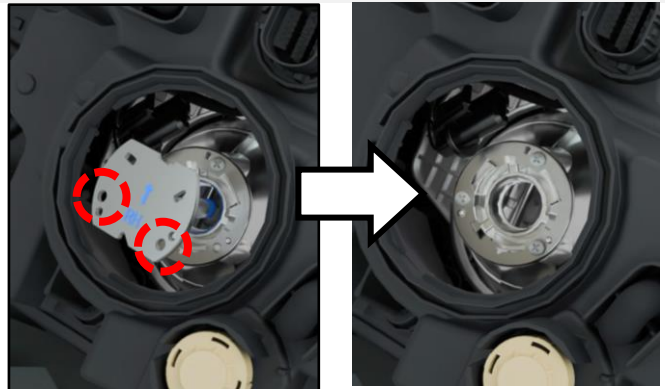
27. Remove the shield fixing jig (H) in the reverse order of removal and reinstall the two (2) removed screws.

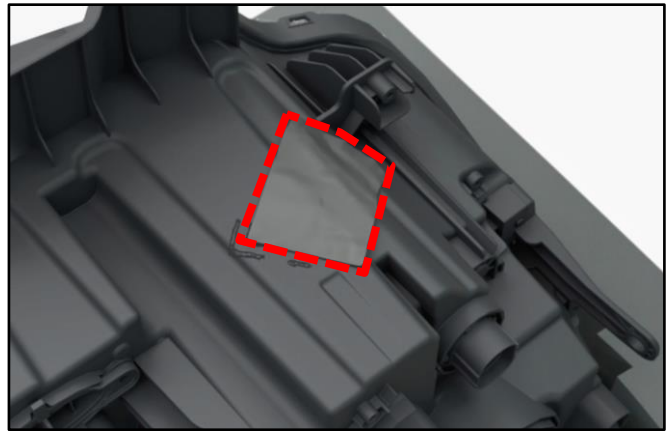
34. Align the provided small pad (PN 92100 S9003QQK) over the hole opening, as shown and adhere it to the surface.

35. Using a heat gun, apply heat over the pad to increase adhesion while applying downward pressure to help mold the pad to the surface.

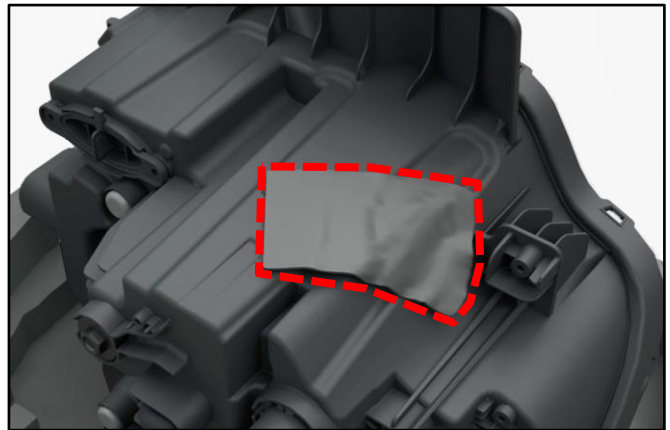
36. Align the large pad (PN 92100 S9004QQK) over the adhered small pad, as shown.

37. Using a heat gun, apply heat over the pad to increase adhesion while applying downward pressure to help mold the pad to the surface.
