SAFETY RECALL - 24TA05

POTENTIAL AXLE SHAFT SEPARATION

CERTAIN 2022-2023 TACOMA

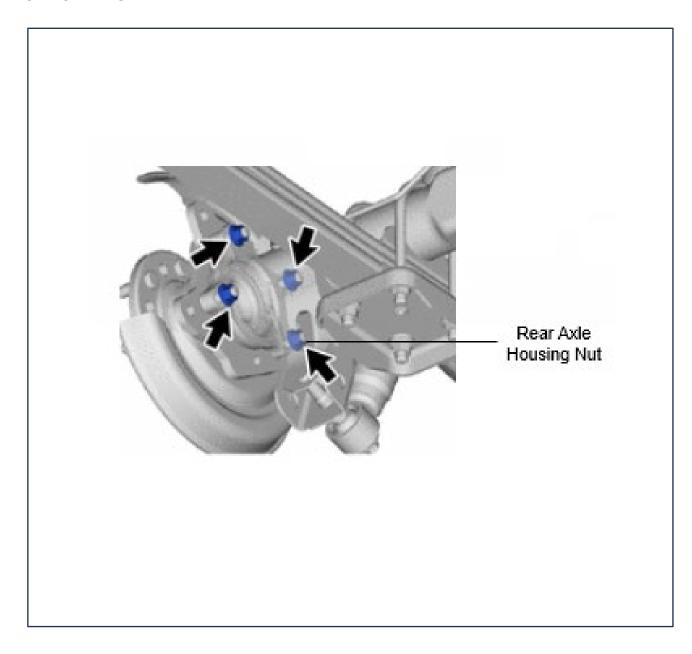
VI. COMPONENTS

Welding debris left on the ends of the rear axle assembly during manufacturing could cause certain retaining nuts to loosen over time and eventually fall off, potentially causing a part to separate from the axle. If separation occurs, this can affect vehicle stability and brake performance, increasing the risk of a crash.
