# Safety Recall

## N242441050 Mobileye Camera Cable Pinched

**Release Date:** March 2024

Make	Model	Model Year		RPO	Description
		From	To		
Chevrolet	6500 XD/7500 XD Low Cab Forward	2020	2024	Y65	Forward Collision Alert and Lane Departure Warning (Mobileye)

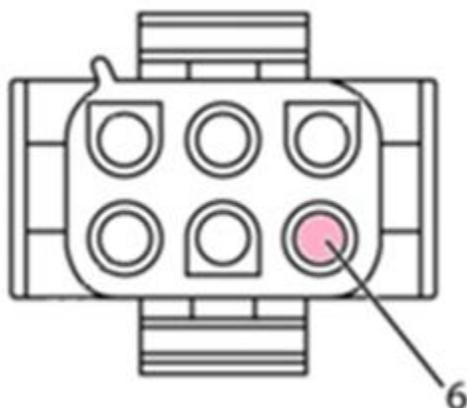
6584372

7. Using an ohm meter, test for continuity between the male end of connector MH-2 Pin 6 (pink wire) and body ground.
  - a. If the wire has continuity to ground, the camera cable must be replaced. See the Parts Information section above for more information.
  - b. If the wire has no continuity to ground, reconnect connector MH-2 and go to Step 8.

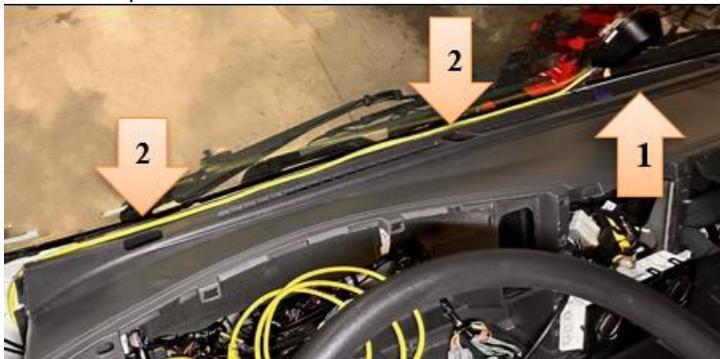
6593074

14. Inspect the cable in the two (2) areas nearest the IP mounting bolt locations indicated by arrows marked (1).
