BULLETIN

BULLETIN NUMBER:
CB24-R-001

IMPORTANT SAFETY RECALL

F-SERIES MOBILEYE CAMERA CABLE ROUTING – 24V-157

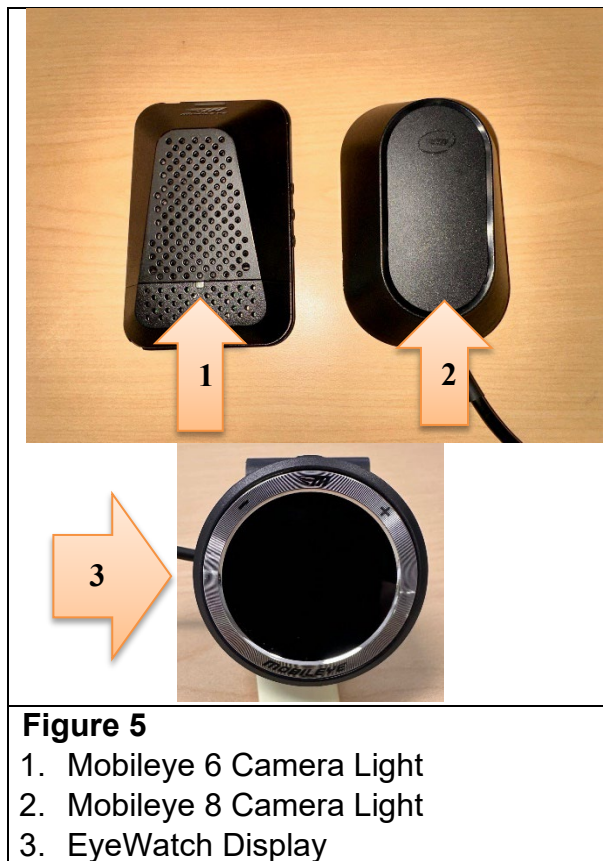
1. With the Engine Control Switch turned to the “ON” position, engine “OFF”, move the turn signal lever to the left turn or right turn position and confirm that each indicator on the instrument panel cluster operates properly. Confirm that the light on the Mobileye camera is on and no codes are present in the EyeWatch display. (See Figure 5.)

- a. If one or both of the turn signal indicators do not function properly (e.g. both indicators flash simultaneously), the camera cable must be replaced. Refer to the Parts Information section above for more information.
 - b. If no problem was found, continue to the next step.
2. Turn the Engine Control Switch to the “Lock” position, wait at least three minutes and then disconnect the negative battery cable.

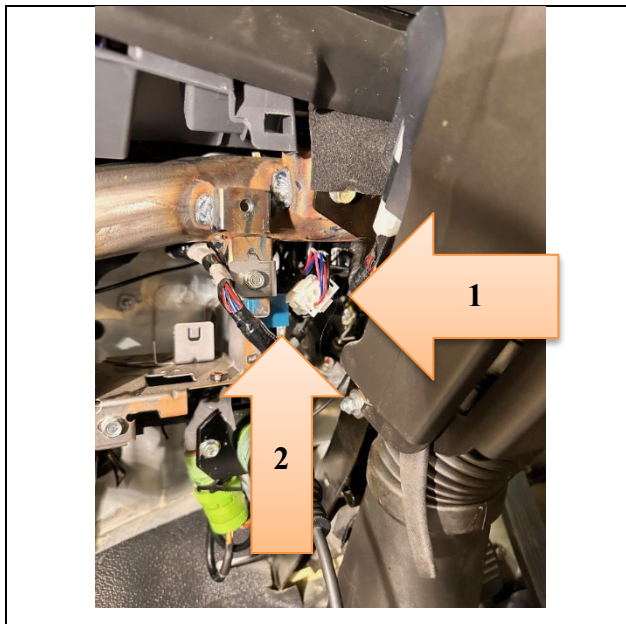
Figure 9
1. Connector MH-2
2. Flasher Module Connector B-216

6. Disconnect connector MH-2 located near and slightly above the B-216 Flasher Module. (See Figure 9.)

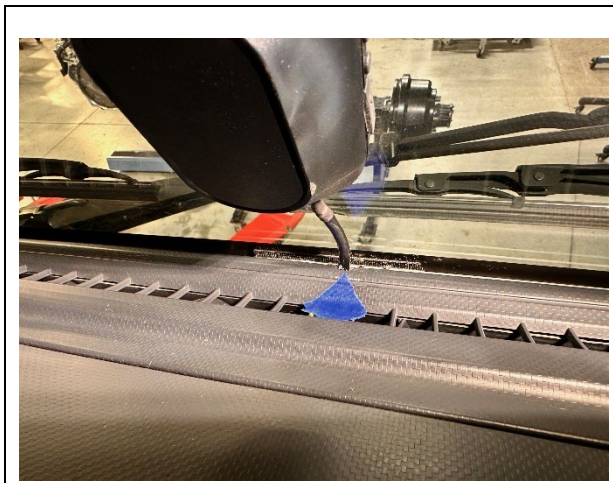
Figure 11
Tape location

8. Using one (1) inch of masking tape, mark the location near the center of the instrument panel where the Mobileye camera cable goes under the instrument panel. (See Figure 11.)

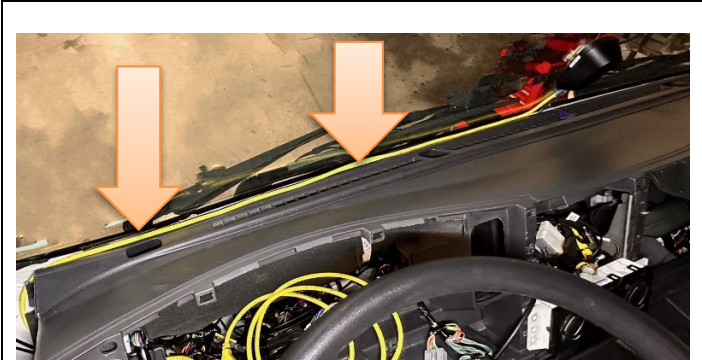
13. Pull back on the IP and remove the Mobileye camera cable from behind the instrument panel. (See arrows in Figure 16.)

Figure 16
Camera cable to be removed from behind the instrument panel (shown in Yellow).

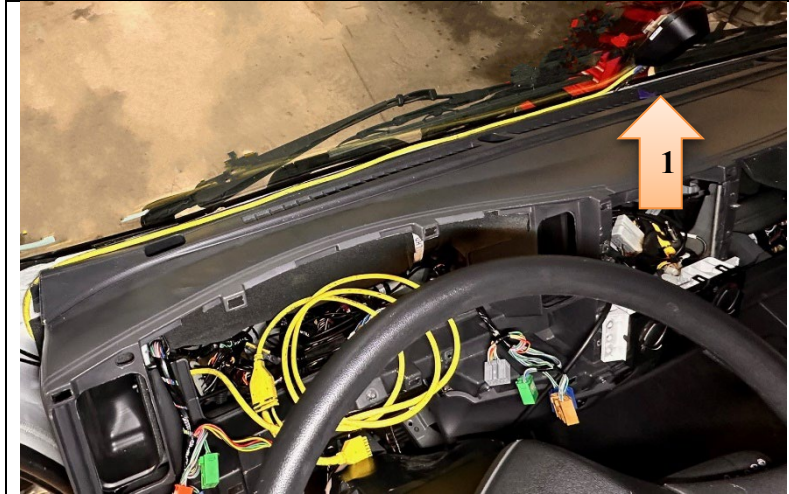
Figure 27
Current Cable Routing (painted yellow for reference.)
1. Tape Location

22. Pull out the entire camera cable from its current routing and lay it on top of the IP to the right of the tape mark placed in Step 8. (See Figure 27.)

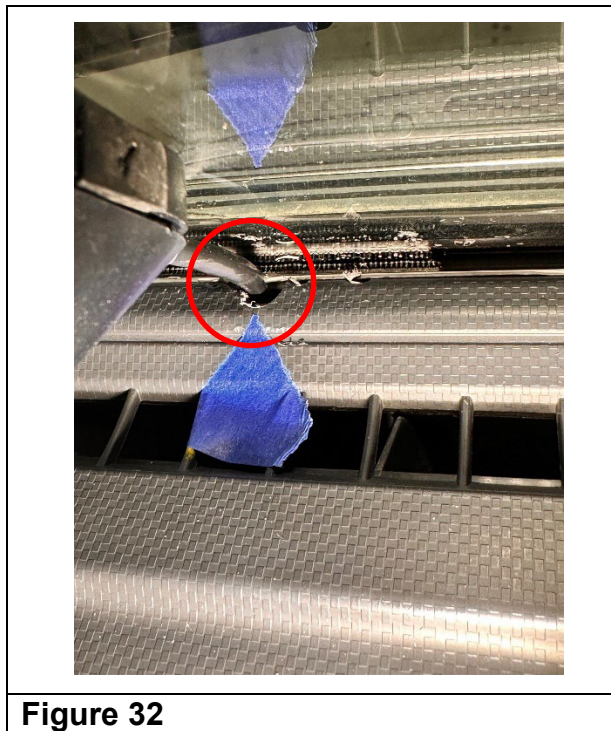
Figure 32

27. Remove the block or item used to maintain the gap between the IP and the windshield and set the IP back into place. Make sure that the camera cable is routed through the new notch in the IP. (See Figure 32.)

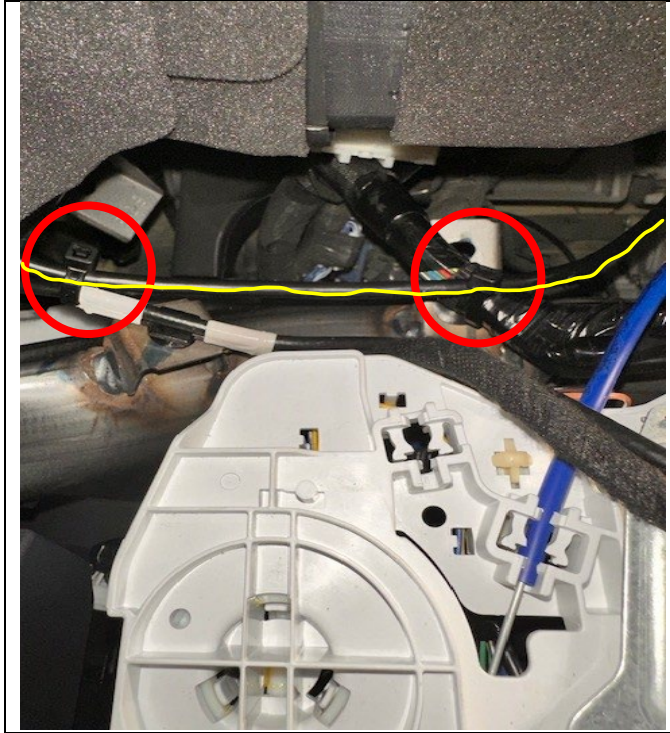
Figure 33
Camera Cable Zip Tie Location

28. Install two (2) zip ties to secure the camera cable behind the A/C control panel. If needed, pull out the cup holder for additional access. (See Figure 33.)

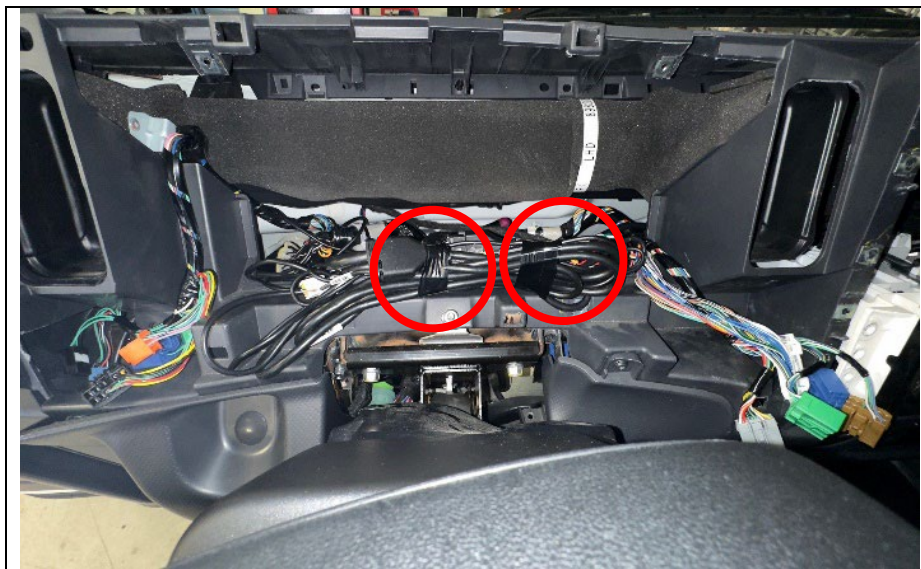
Figure 34

29. Bundle the Mobileye harnesses back together and secure them with electrical tape in the two locations shown in Figure 34.

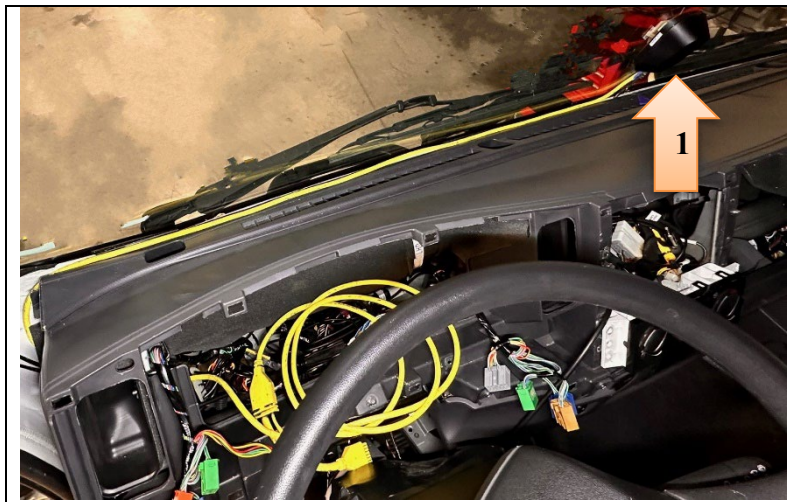
Figure 61
Current Cable Routing (painted yellow for example.)
1. Tape Location

60. Pull out the entire camera cable from its current routing and lay it on top of the IP to the right of the tape mark placed in Step 49. (See Figure 61.)
