# Campaign Service

**BULLETIN NUMBER:**  
CB24-R-001B

## IMPORTANT SAFETY RECALL

### F-SERIES MOBILEYE CAMERA CABLE ROUTING – 24V-157

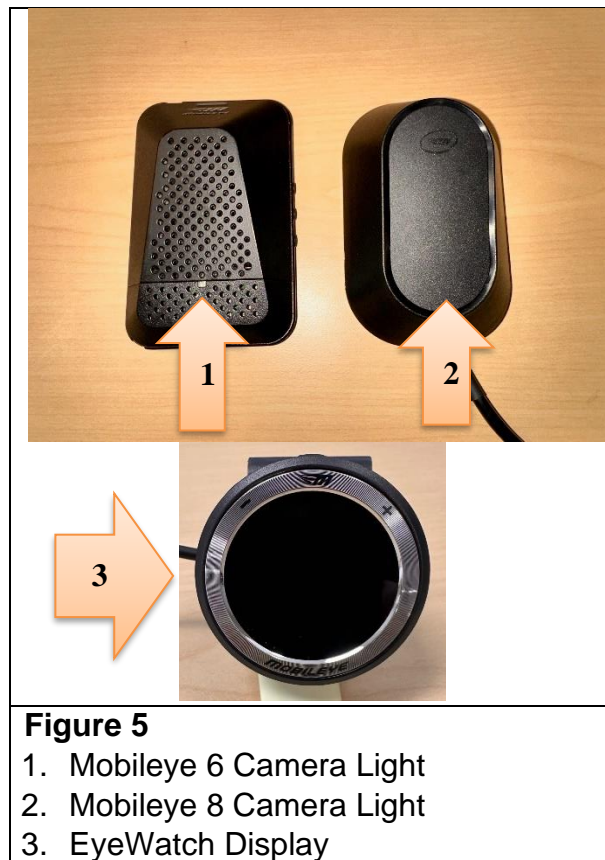
1. With the Engine Control Switch turned to the “ON” position, engine “OFF”, move the turn signal lever to the left turn or right turn position and confirm that each indicator on the instrument panel cluster operates properly. Confirm that the light on the Mobileye camera is on and no codes are present in the EyeWatch display. (See Figure 5.)

- a. If one or both of the turn signal indicators do not function properly (e.g. both indicators flash simultaneously), the camera cable must be replaced. Refer to the Parts Information section above for more information.
  - b. If no problem was found, continue to the next step.
2. Turn the Engine Control Switch to the “Lock” position, wait at least three minutes and then disconnect the negative battery cable.

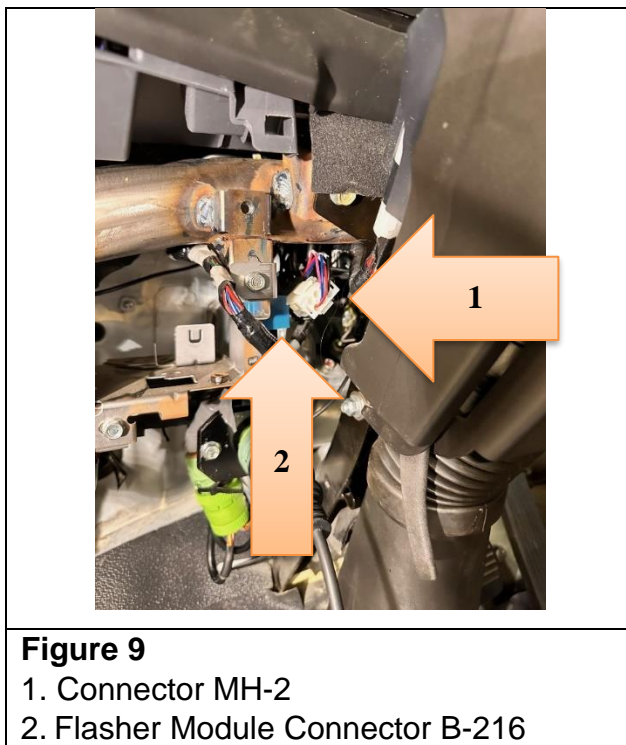
6. Disconnect connector MH-2 located near and slightly above the B-216 Flasher Module. (See Figure 9.)

7. Using an ohm meter, test for continuity between the male end of connector MH-2 Pin 6 (pink wire) and body ground. (See Figure 10.)

- a. If the wire has continuity to ground, the camera cable must be replaced. See the Parts Information section above for more information.
- b. If the wire has no continuity to ground, reconnect connector MH-2 and go to Step 8.

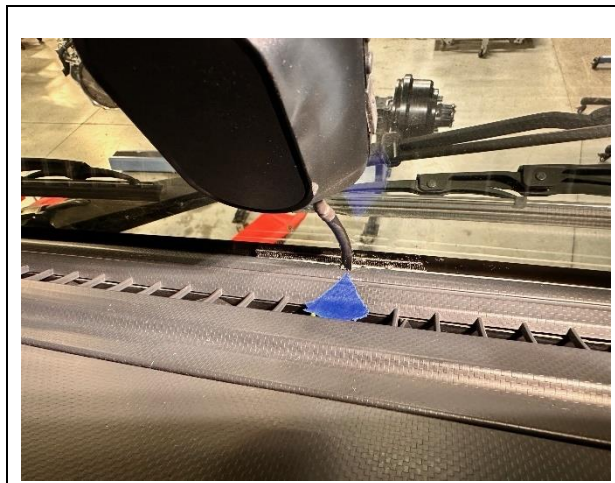
**Figure 11**  
Tape location

8. Using one (1) inch of masking tape, mark the location near the center of the instrument panel where the Mobileye camera cable goes under the instrument panel. (See Figure 11.)

25. Using a rotary cutting tool or rat tail file, create a notch (relief) in the IP at the location previously marked in Step 8 where the camera cable will pass between the IP and the windshield. The notch should be at least one-quarter (1/4) inch in depth and in diameter. (See Figure 30.)

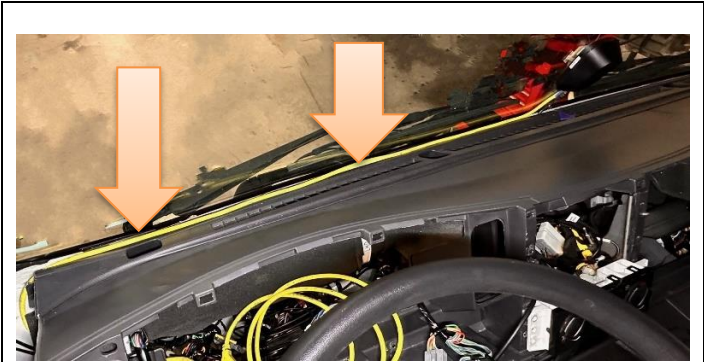
**Figure 16**  
Camera cable to be removed from behind the instrument panel (shown in Yellow).

13. Pull back on the IP and remove the Mobileye camera cable from behind the instrument panel. (See arrows in Figure 16.)

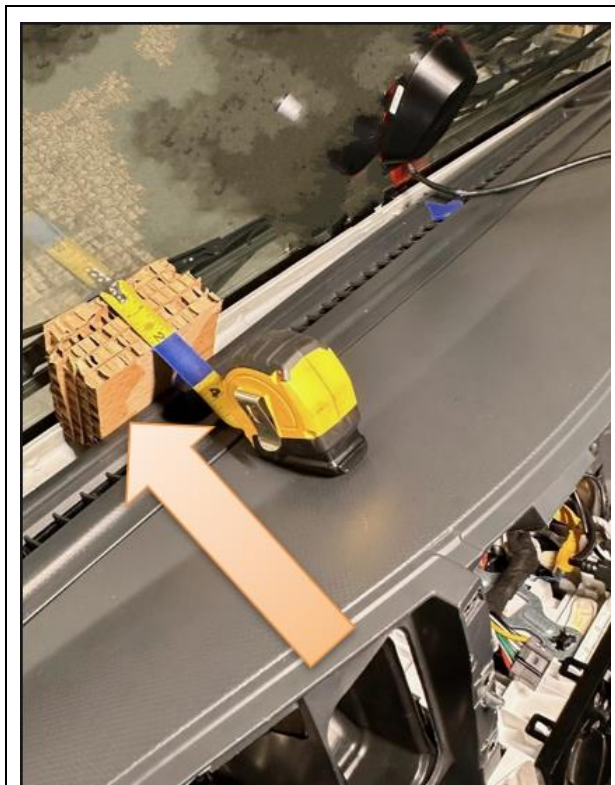
**Figure 28**  
Item wedged between IP and windshield.

23. Pull the IP away from the windshield to create a 2" gap between the IP and the windshield as shown in Figure 28. Place a piece of wood, cardboard or rubber block (e.g. rubber mallet head) directly inline from the driver's right HVAC vent to maintain this gap.

***IMPORTANT: Do not place too much pressure on the windshield! Doing so may result in a broken windshield!***

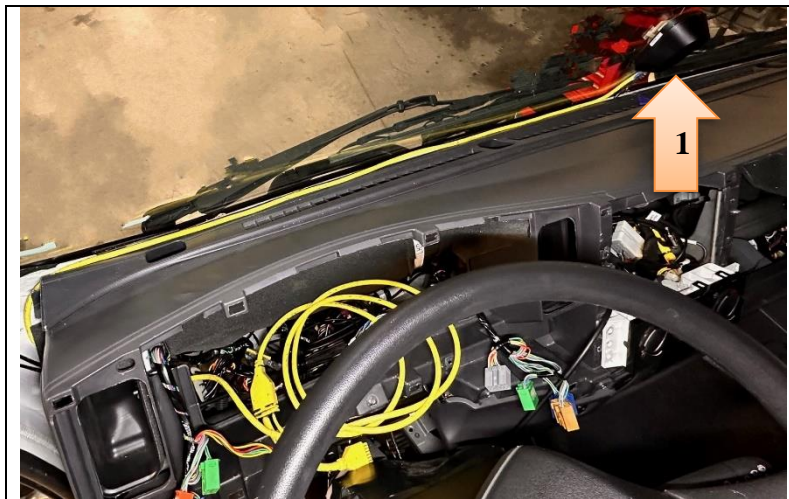
**Figure 61**

- Current Cable Routing (painted yellow for example.)  
1. Tape Location

60. Pull out the entire camera cable from its current routing and lay it on top of the IP to the right of the tape mark placed in Step 49. (See Figure 61.)

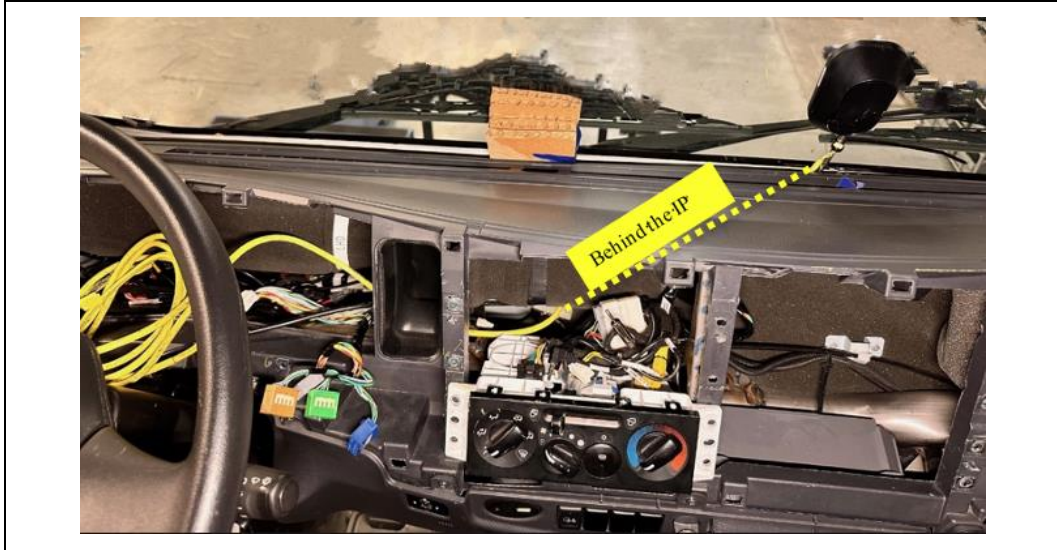
**Figure 70**

New camera cable routing (painted in Yellow for reference).

72. Install and tighten the two (2) camera mounting screws removed in Step 64 to attach the camera chassis to the camera frame. (See Figure 64.)
73. **For Mobileye 8**, install and tighten the three (3) screws for the main back cover removed in Step 63. If equipped with Mobileye 6 install and tighten the two (2) lower screws. (See Figure 63.)
74. **For Mobileye 8**, re-install the oval cover onto the back of the Mobileye camera. If equipped with **Mobileye 6**, re-install the rectangular cover. (See Figure 62.)
75. Route the new camera cable down, behind and under the instrument panel and HVAC duct toward the radio opening. If necessary, pull out the cup holder for more access. Grab the end of the camera cable and pull out the remaining length of cable. Loosely route the cable from the radio opening into the area behind the instrument panel cluster. (See Figure 70.)

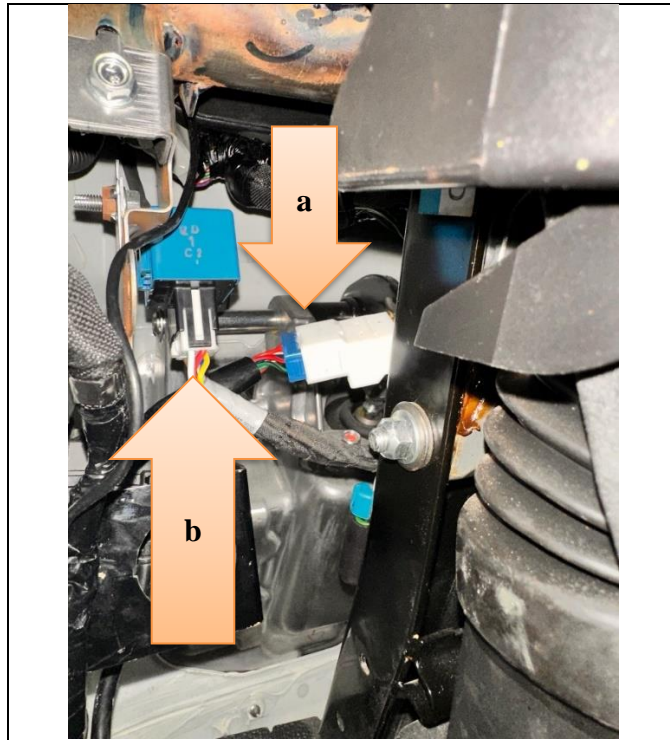
**Figure 83**

- a. Connector B-216  
b. Flasher Module Connector

87. Disconnect the old T-Harness from both B-216 and the flasher module and remove the old T-Harness from the vehicle. (See Figure 83.)

88. **For Mobileye 8** only, disconnect the old T-Harness from both the B-216 connector and the flasher module and remove the old T-Harness and signal harness from the vehicle.
89. Install the new T-Harness into the connector B-216 and the flasher module. Refer to Figure 83.
