GROUP	MODEL
Safety Recall Campaign	2019-2020MY K900 (RJ) and 2018-2023MY Stinger (CK) w/Lambda II 3.3L T-GDI
NUMBER	DATE
SC300 (Rev 1, 5/16/2024)	April 2024

LEFT-HAND OIL FEED PIPE AND HOSE ASSEMBLY REPLACEMENT (SC300)

This bulletin provides information to replace the left-hand (LH) turbocharger oil feed pipe and hose assembly on certain 2019-2020MY K900 (RJ) vehicles produced from August 8, 2018 through August 24, 2020 and 2018-2023MY Stinger (CK) vehicles produced from September 21, 2017 through June 29, 2022, equipped with a Lambda II 3.3L T-GDI engine. Over time, the left-hand (LH) turbocharger oil feed pipe and hose assembly may deteriorate due to exposure to radiant heat from the exhaust manifold. Such deterioration can lead to oil leaks, which in the presence of hot exhaust components, increases the risk of an engine compartment fire while driving. A fire increases the risk of injury. Customers may experience oil leaking, burning smell, white smoke from engine compartment and/or illumination of the engine oil pressure warning light. Follow the procedure outlined in this publication to replace the LH turbocharger oil feed pipe and hose assembly with an improved one on the a

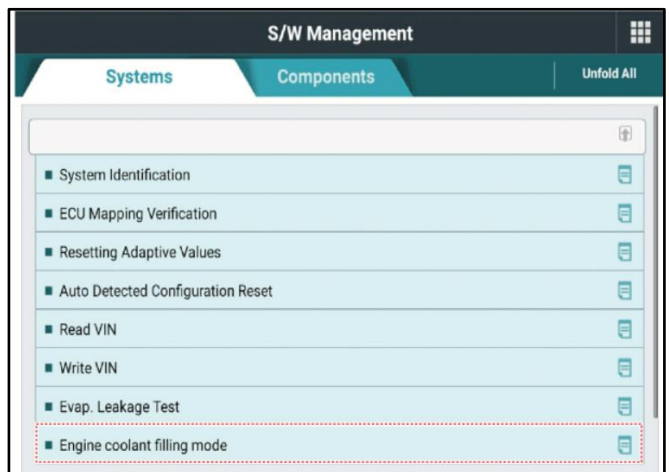
28. Refill the lost engine oil from LH oil feed pipe and hose assembly leak.
Refer to KGIS for oil specifications NPNENG5W30

26c. **Replace** the LH oil feed pipe (Z) with the new and improved part.

27. Reinstall all removed parts in reverse order of removal.

29. Perform the coolant filling and air bleeding procedure by referring to "Engine Mechanical System → Coolant → Repair procedures" in the applicable Shop Manual on KGIS.
