GROUP	MODEL
	Subsequent Repair Action	2022-2024MY EV6, EV6 GT (CV)
	NUMBER	DATE
	SC302Y	June 2024

SUBJECT: **ICCU AND FUSE REPLACEMENT (SC302Y)**

This bulletin provides information related to the Technical Service Bulletin previously published under SC302, titled "ICCU and Fuse Inspection/Replacement and ICCU Software Upgrade." If DTC P1A9096 is present or stored after ICCU Software Upgrade has been performed per SC302, follow the instruction in this bulletin to replace the ICCU and ICCU fuse. Before conducting the procedure, verify that the vehicle is included in the list of affected VINs.

DTC Description:
P1A9096 - DC/DC Converter Input Voltage Sensor Fault

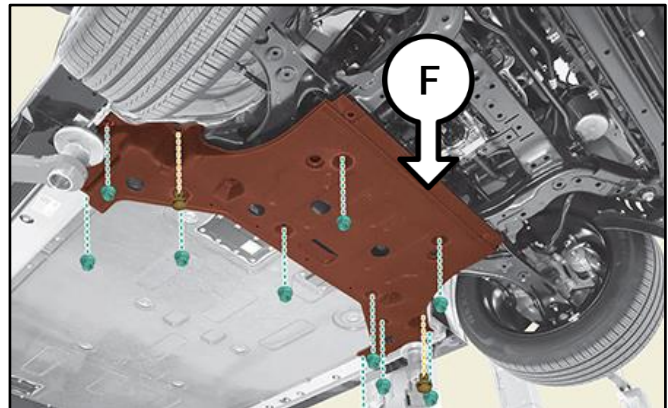
Front of Battery

7. Remove the front rear under cover (F).

Note: Image shown for reference only. The front under cover does not need to be removed.
