Technical Service Bulletin

GROUP	NUMBER
RECALL	24-01-023H
DATE	MODEL(S)
MARCH 2024	IONIQ 5 (NE1) IONIQ 6 (CE1) IONIQ 5 (NER) ROBOTAXI

SUBJECT: DTC P1A9096 CHECK FOR ICCU & FUSE REPLACEMENT & ICCU SOFTWARE UPDATE (RECALL 257)

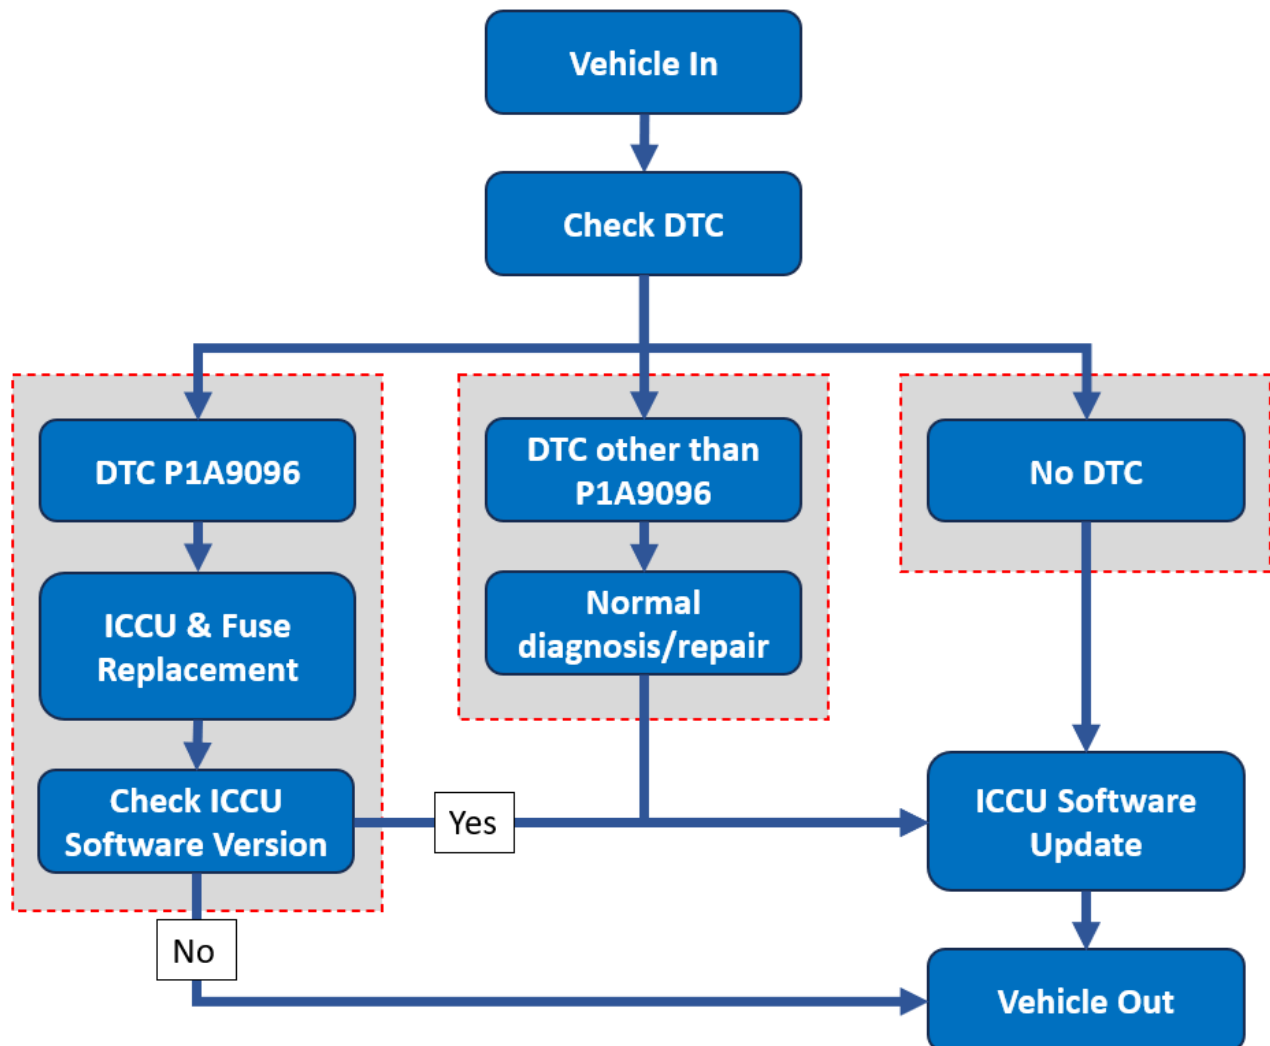
Service Procedure Flow:

The Service Procedure flow to be followed is outlined by the flowchart on Page-3. The ICCU system is to be checked by GDS for DTC P1A9096 and depending on the result, will involve either an ICCU software update, or ICCU and potential fuse replacement. Only replace the fuse after it is inspected to confirm to be blown/open.

- A1. Perform All Fault Search by GDS.
- A2. Check the ICCU system for DTC P1A9096 either found as an active or history DTC?
- **No – (DTC P1A9096 is not found stored):**
 - **Perform ICCU Software Update – see section B. (Campaign Claim 0.4 M/H)**
 - NOTE: If any other DTC or symptom is found stored, diagnose and repair per shop manual before performing the ICCU Update. **(Warranty Claim)**
 - **Yes – (DTC P1A9096 is found stored):**
 - **Replace ICCU:**
 - IONIQ 5 (NE1) 2022-2024MY– see section C
 - IONIQ 5 ROBOTAXI (NER) – see section C (Contact Techline for Info)
 - IONIQ 6 (CE1) 2023-2024MY– see section D
 - **Replace the Fuse – see section E.**
(Notice: Replace the High Voltage Fuse in conjunction with the ICCU. Failure to do so may result in PRA damage.)
(Campaign Claim 2.1 M/H)

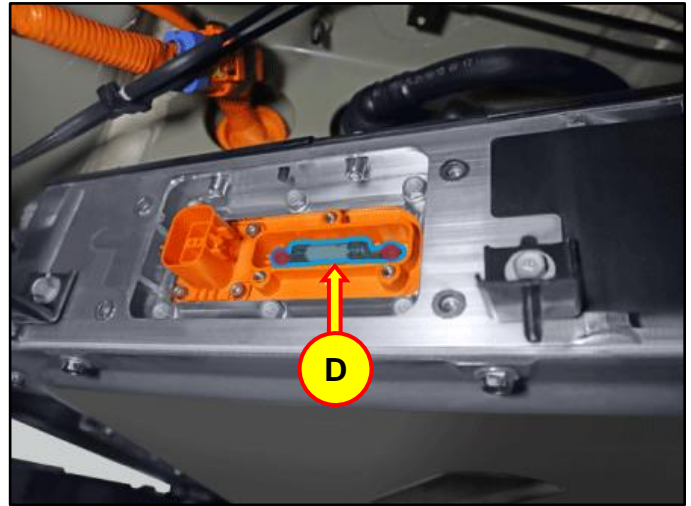
There can be difficulty removing the fuse, which may include the nuts of the at the back of the fuse holder falling back into the battery.

See the below special instruction should this occur.

E8. Install the supplied replacement part ICCU Fuse.

Install back in the reverse order of removal.
