**SIB 72 01 24**

RECALL 24V-288: HEAD AIR BAGS LEFT AND RIGHT

This Service Information Bulletin (Revision 1) replaces SI B72 01 24 **dated April 2024**.

RE: Recall 24V-288: Head Air Bags Left and Right – B72 01 24

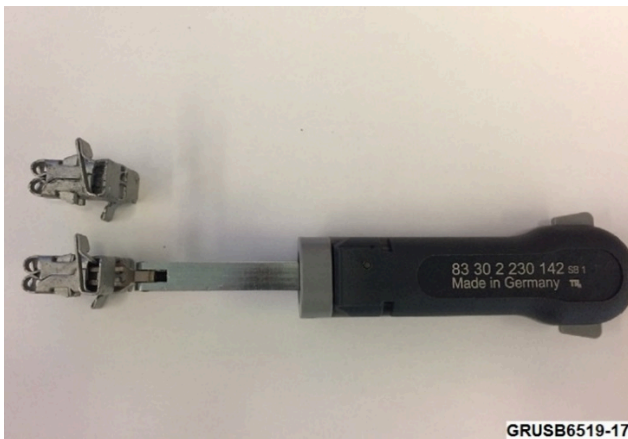
Here is a spring clip that holds the air bag assembly into the body in its installed state.

Special Tool **83 30 2 230 142** or its supersession **83 30 2 450 405** is needed to release the spring clips that hold the air bag assembly into the body.

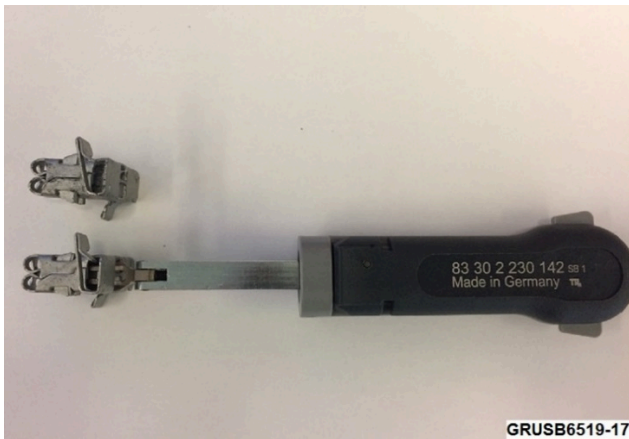
Here is a spring clip that holds the air bag assembly into the body in its installed state.

Special Tool **83 30 2 230 142** or its supersession **83 30 2 450 405** is needed to release the spring clips that hold the air bag assembly into the body.

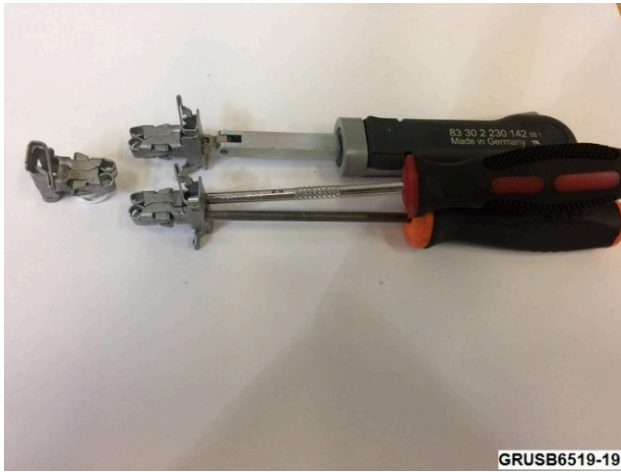
Clip with tool 2 230 142 inserted with spring clips pulled inward by tool

These tools were shipped to dealers previously under the Automatic Tool Shipment Program. If the tool is not available, two straight pick tools can be used.
