SIB 72 01 24

**RECALL 24V-288: HEAD AIR BAGS LEFT AND RIGHT**

This Service Information Bulletin (Revision 3) replaces SI B72 01 24 **dated December 2024**.

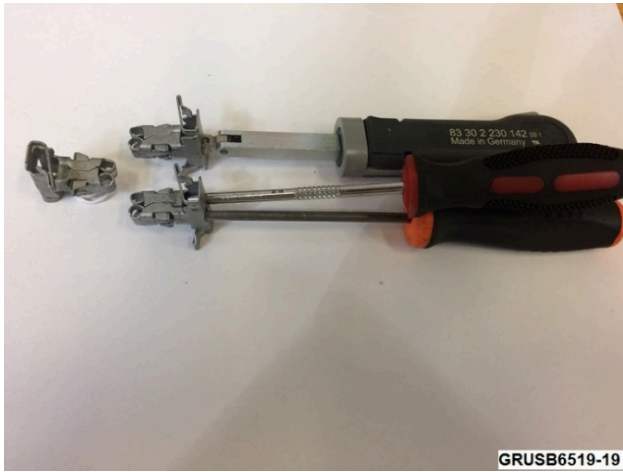
Clip with tool 2 230 142 inserted with spring clips pulled inward by tool

These tools were shipped to dealers previously under the Automatic Tool Shipment Program. If the tool is not available, two straight pick tools can be used.

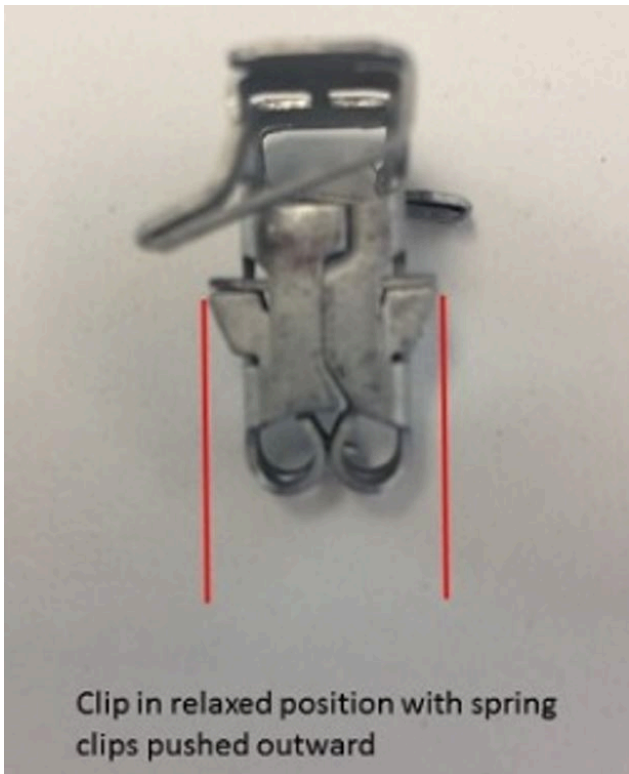
Here is a spring clip that holds the air bag assembly into the body in its installed state.
