SIB 72 03 24

RECALL 24V-288: HEAD AIR BAG RIGHT

This Service Information Bulletin (Revision 2) replaces SI B72 03 24 **dated September 2024**.

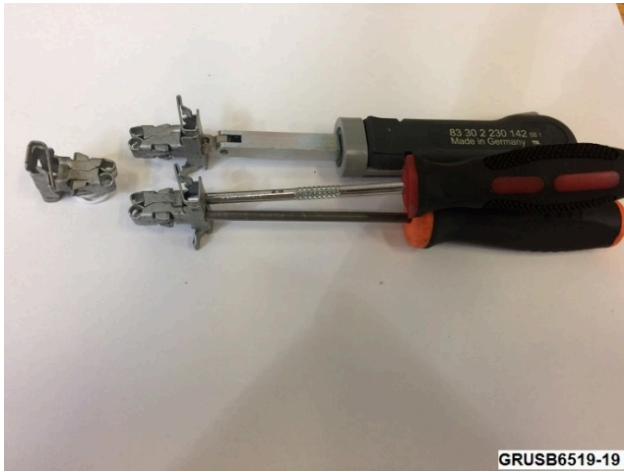
Clip with tool 2 230 142 inserted with spring clips pulled inward by tool

These tools were shipped to dealers previously under the Automatic Tool Shipment Program. If the tool is not available, two straight pick tools can be used.
