# Recall Campaign Bulletin

Campaign No. 2024050002, May 2024

SUBJECT: **Model GL-Class, ML-Class, and R-Class (X164, W164 and 251 platform)  
Model Year 2006 – 2012**

## **Inspect Brake Booster – with Pedal Rework**

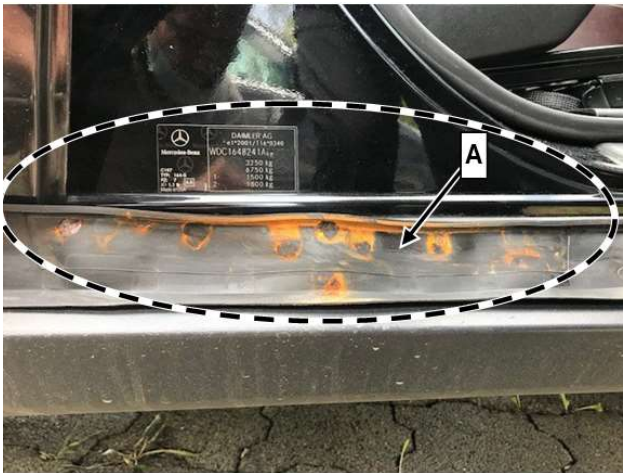
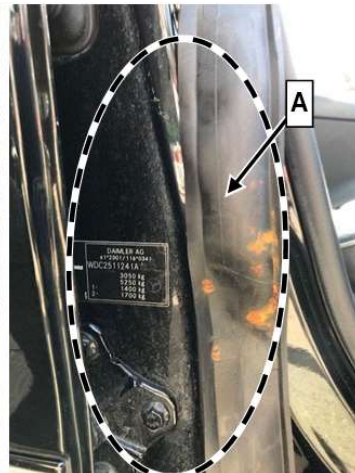
3. Take a photo of the rubber sleeve with the VIN label of the B-pillar (**Figures 3 and 4, A**) and store to a local HDD/computer storage location with the vehicle service file and attach it to the warranty claim in EVA.
  - i** These pictures serve as documentation of the current condition of the brake booster.

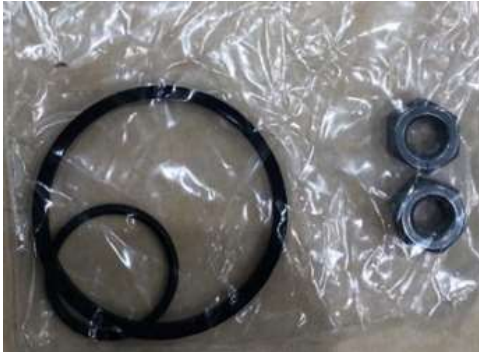
Figure 12

**i** The new brake booster contains a small parts kit (**Figure 12**).

1. Replace brake booster.
