GROUP	NUMBER
RECALL	24-01-040H
DATE	MODEL(S)
MAY 2024	Elantra (CN7) Venue (QX) Kona (SX2)

EGR VALVE ASSEMBLY& GASKET REPLACEMENT (RECALL 260)

Description: The exhaust gas recirculation ("EGR") valve assembly in certain vehicles (listed below) may contain a sensor that was contaminated with solder flux during manufacturing, which could potentially result in an electrical short. An electrical short within the EGR valve could lead to a malfunction of the EGR valve or crank position sensor, both of which reside on the same power circuit, resulting in Malfunction Indicator Lamp illumination (P240F, P404, P0405, P049D, P0642, P0652) and/or a sudden loss of motive power during operation. Follow the information below to replace the EGR valve assembly and gasket.

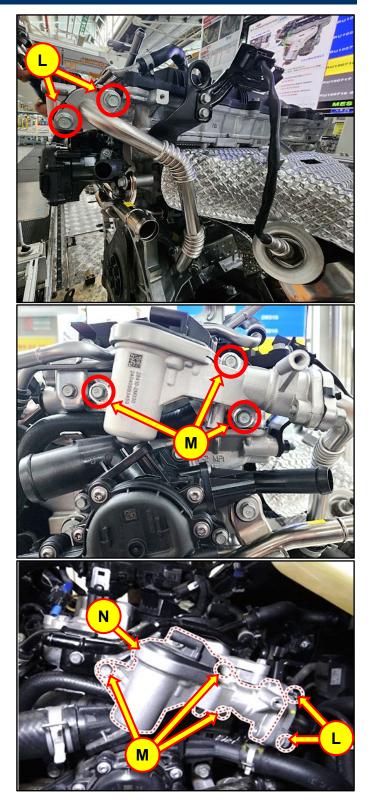
9. Disconnect the EGR connector and remove the EGR pipe mounting bolts (L).

Remove the EGR control valve mounting bolts (M) and remove the EGR valve (N).

10. Install the supplied EGR valve and gasket.

Inspect component before use; dropping components may cause internal damage.

Prevent foreign material from entering the valve.
