L636-  
R.02.24

**Campaign code:**  
L636-R.02.24

**Campaign Name:**  
Carbon Engine Hood

**Model:**  
Urus S, Urus Performante

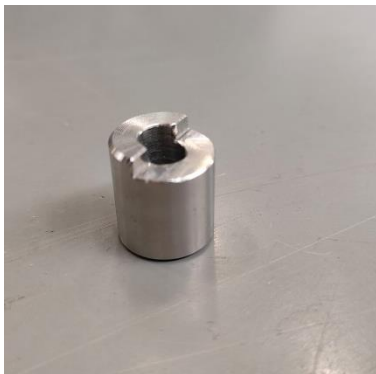
- 5. Continue to do the same for the fast lock striker on the opposite side.
- 6. Perform the check using the pass/no pass tool in the kit.

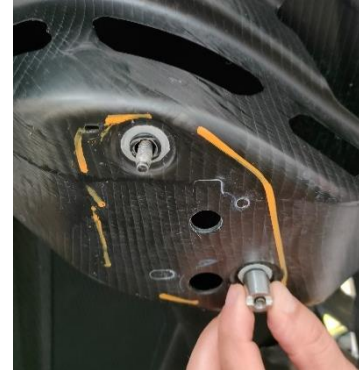
- 7. Place the tool on the two threaded rivets of the striker and check that the length of the rivet is within the desired tolerance or between the two shoulders.

Continue to do the same for the fast lock striker on the opposite side.
