# SAFETY RELATED RECALL

Global Recall Action  
Number: N901

<b>Subject:</b>  <b>Rear Surround Camera Bezel Water Ingress</b>	Publication No.: N901
	Model: Range Rover Sport (LW)
	Model Year: 2018 - 2022
	Date of Issue: 29 May 2024

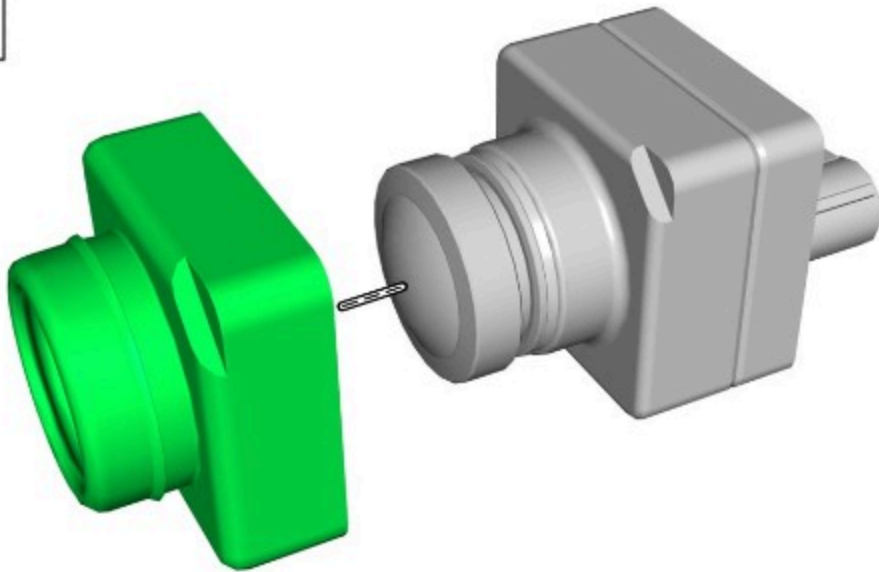
E354267

- Inspect the rear surround camera housing and lens adhesive for corrosion. If there **ARE** any signs of corrosion on the rear surround camera housing, as shown in the illustration marked 'A' the rear surround camera has **FAILED** the inspection. **Continue to step 7.**
- Inspect the rear surround camera lens for water ingress. If there **ARE** any signs of water ingress on the rear surround camera lens, as shown in the illustration marked 'B' the rear surround camera has **FAILED** the inspection. **Continue to step 7.**
- If there are no signs of corrosion or water ingress on the rear surround camera housing the rear surround camera has **PASSED** the inspection. **Continue to step 6.**

4. Remove and discard the rear surround camera seal.
