MODEL: Revero GT and GTS, and GS-6

Type: Safety Recall Campaign

TITLE: Headlamp Control Unit Replacement Safety Recall Campaign

APPLICABILITY: Model Year 2020-2022 Karma Vehicles

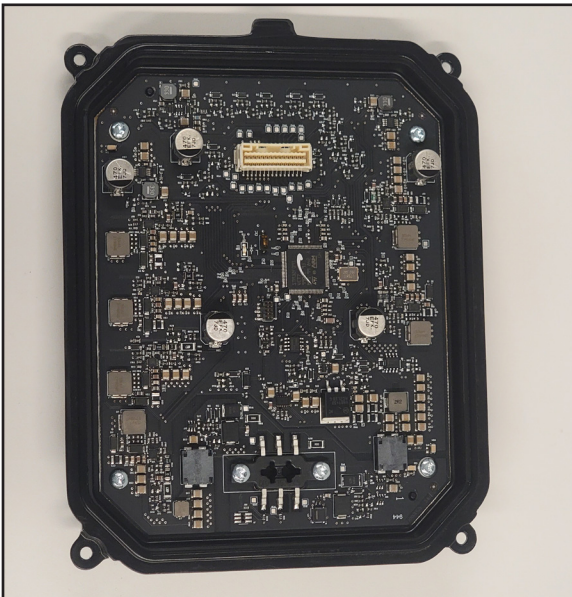
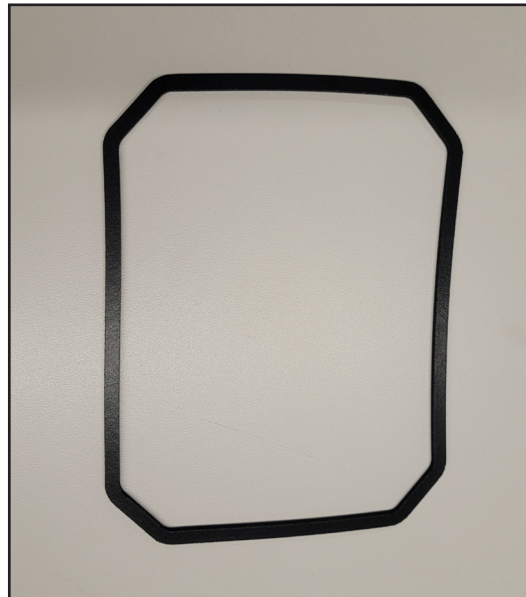
These kits are composed components of the control module (shown below) and 4 (T15) new fasteners, per side, and a new gaskets, again 1 per side.

Fastening torque is 14 in-lbs. The gasket should be installed on the headlamp body gasket channel as described in the bulletin below.

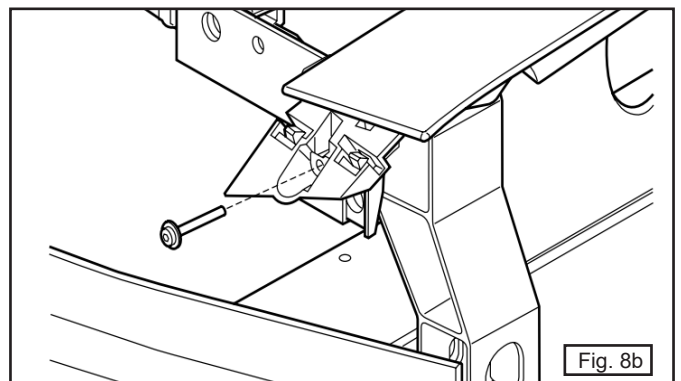
Important: If the side support bracket retaining clip(s) are damaged, or if the front fascia side support bracket(s) must be replaced (Fig. 8b).

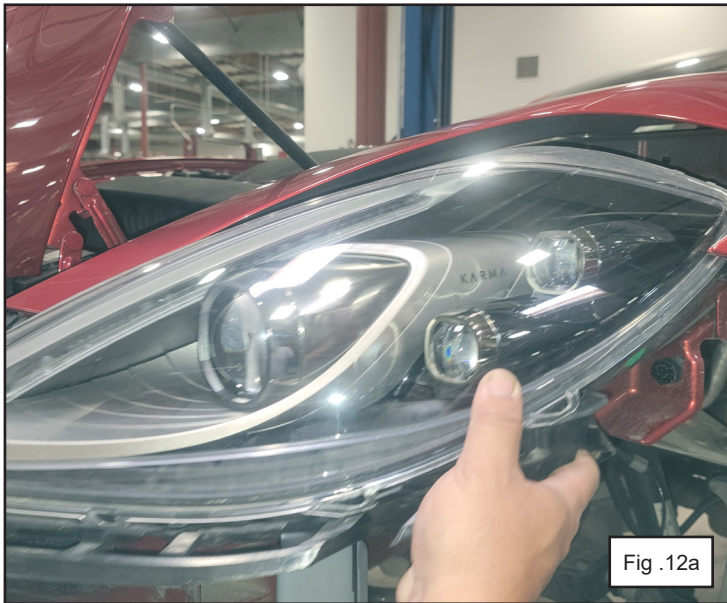
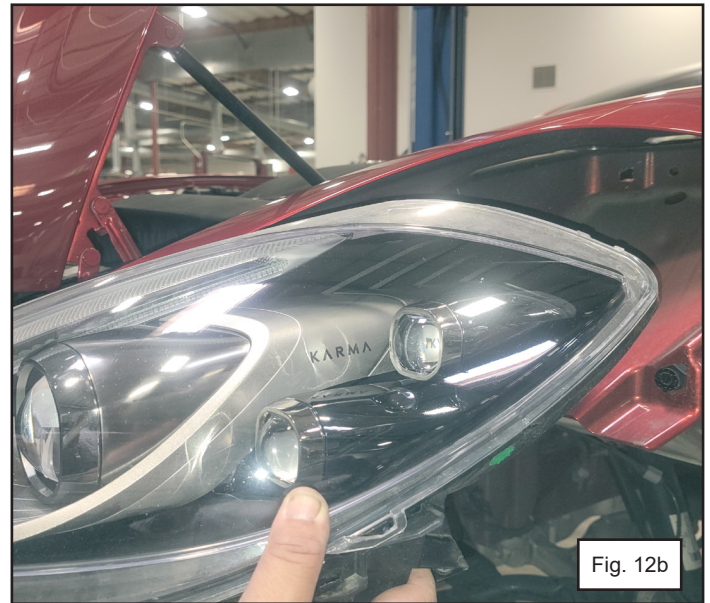
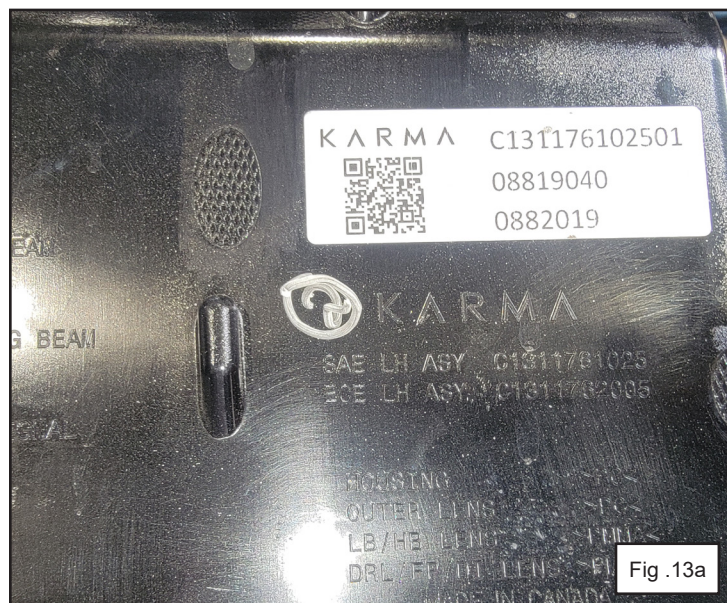
17. With all the fasteners removed, pull the headlamp forward to remove (Fig.12a, and Fig.12b). Set this aside. An image of the headlamps prior to removal and an image of part number on the affected headlamps, should be provided to TSS (Fig.13). The part number is located on the label on the underside of the headlamp. The parts may be requested to be sent back to Karma Automotive, verify instructions with your TSS representative.

Left hand lamp shown as example.

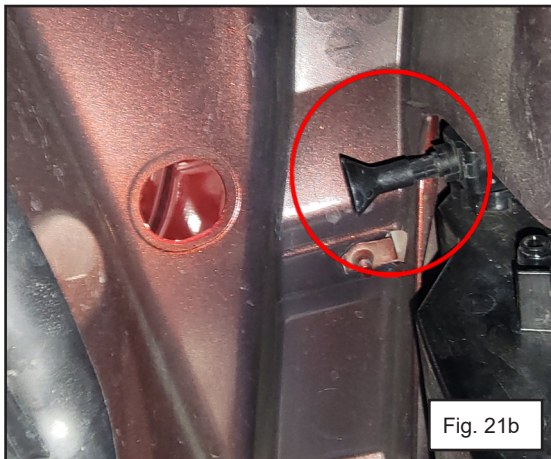
Headlamp adjuster view from under the vehicle (Fig.21b).
