Safety Recall Campaign

SC316

2020-2024MY  
Telluride (ON)

### FRONT POWER SEAT CONTROL SWITCH REPAIR/REPLACEMENT (SC316)

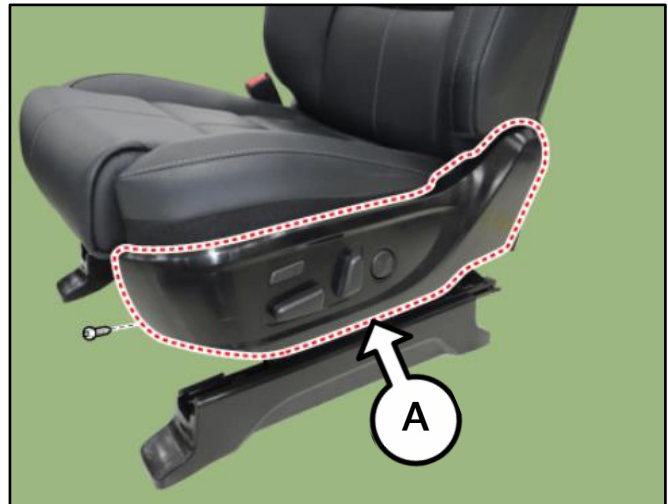
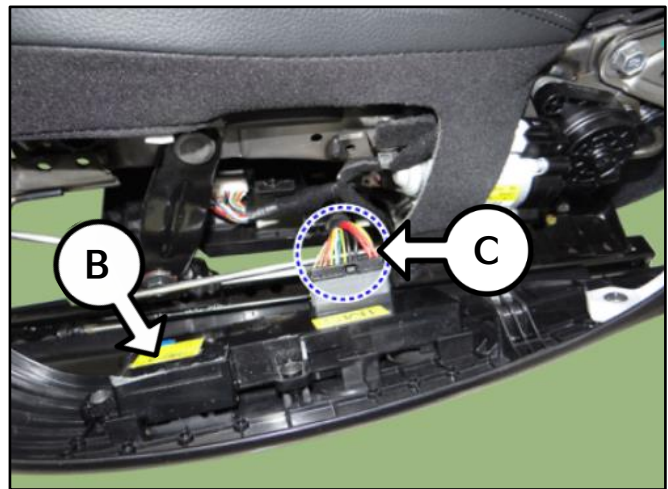
1. Confirm left and right front power seat control switch normal operation.
  - If power seat control switch operation IS normal (**OK**), proceed to step 2.
  - If power seat control switch operation is NOT normal (**NG**), proceed to the 'Replacement Procedure' on page 7.
2. Remove the Front Seat Shield Outer Cover (A) by referring to "Body (Interior and Exterior) → Front Seat → Front Seat Shield Outer Cover → Removal and Inspection" in the applicable Shop Manual on KGIS.
3. Disconnect the power seat control switch (B) connector (C).
