GROUP	MODEL
Safety Recall Campaign	2020-2024MY Telluride (ON)
NUMBER	DATE
SC316 (Rev 2, 8/27/2024)	July 2024

FRONT POWER SEAT CONTROL SWITCH REPAIR/REPLACEMENT (SC316)

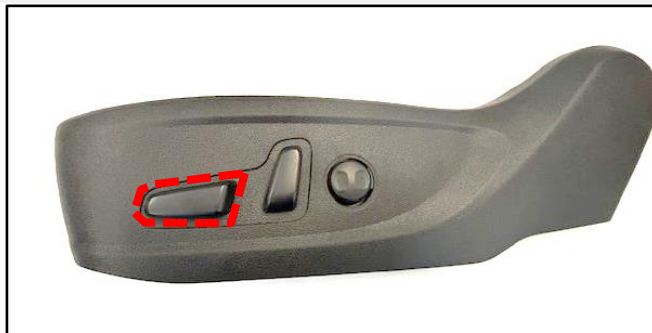
1. Confirm that the slide switch knob (either left, right or both sides) front power seat control switch is operating normally (Refer to the table page 1 for the applicable VIN you are working on).
 - If the power seat control switch slide operation is **normal** (front to rear) and the knob is not binding/sticking (**OK**), proceed to step 2.
 - If the power seat control switch slide operation is **not normal** (front to rear) and/or the knob is binding/sticking (**NG**), skip to the 'Replacement Procedure' on page 6.
