GROUP	MODEL
Safety Recall Campaign	2024MY Sportage (NQ5a)
NUMBER	DATE
SC319	July 2024

SUBJECT: **MDPS POWER PACK ASSEMBLY REPLACEMENT (SC319)**

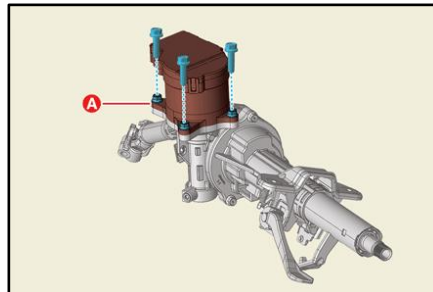
This bulletin provides information to replace the motor driven power steering (MDPS) power pack assembly on certain 2024MY Sportage (NQ5a) vehicles produced from April 30, 2024 through May 23, 2024. During manufacturing by the supplier, the Printed Circuit Board (PCB) in the Motor-Driven Power Steering (MDPS) power pack may have been manufactured with contaminated flux. A contaminated PCB can result in an electrical short circuit. If this occurs, the MDPS power pack may become inoperative resulting in a loss of power steering assist. A loss of power steering assist requires higher steering effort by the driver, especially at low speeds, thereby increasing the risk of a crash. Follow the procedure outlined in this publication to replace the MDPS power pack assembly on the applicable vehicle. Before conducting the procedure, verify that the vehicle is included in the list of affected VINs.

1. Replace the MDPS power pack assembly (A) by referring to "Steering System → Motor Driven Power Steering (MDPS) → MDPS Power Pack Assembly → Removal and Installation" in the applicable Shop Manual on KGIS.
