Date
 Number
 Release
 Page

06. 2024
 SC0446
 01
 1 (5)

Tie Rod Ball Stud AN, PI

RECALL INFORMATION

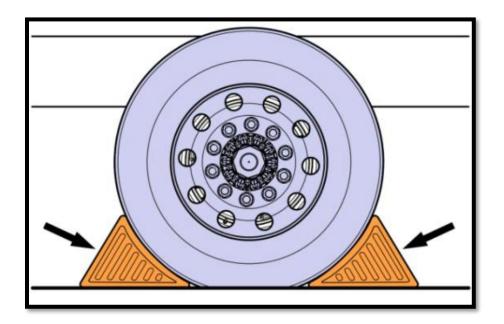
- 1. Secure vehicle for service by parking on a flat and level surface.
- 2. Apply parking brake.
- 3. Place the transmission in neutral or park.
- 4. Install the wheel chocks.
