SAFETY RELATED RECALL

Global Recall Action
Number: [H506v4](#)

Subject: Ingenium I6 3.0L Diesel and Petrol Oil Filter Element Cap - Renew	Publication No.: H506v4
	Model: F-PACE (X761)
	Model Year: 2024
	Date of Issue: 25 November 2024

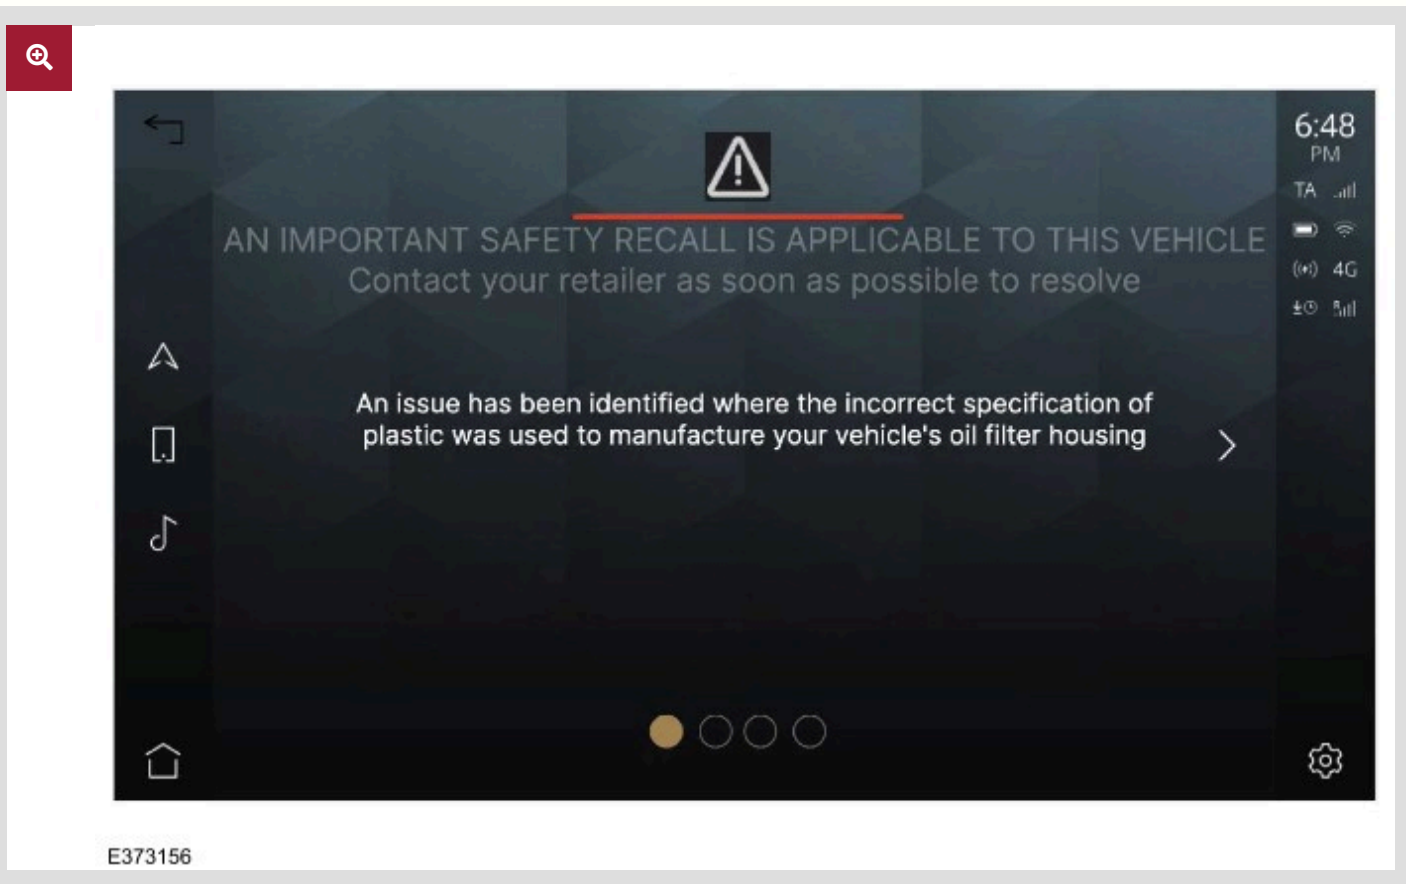
The Touchscreen illustrations below show what will appear in the vehicle as a one time pop up.

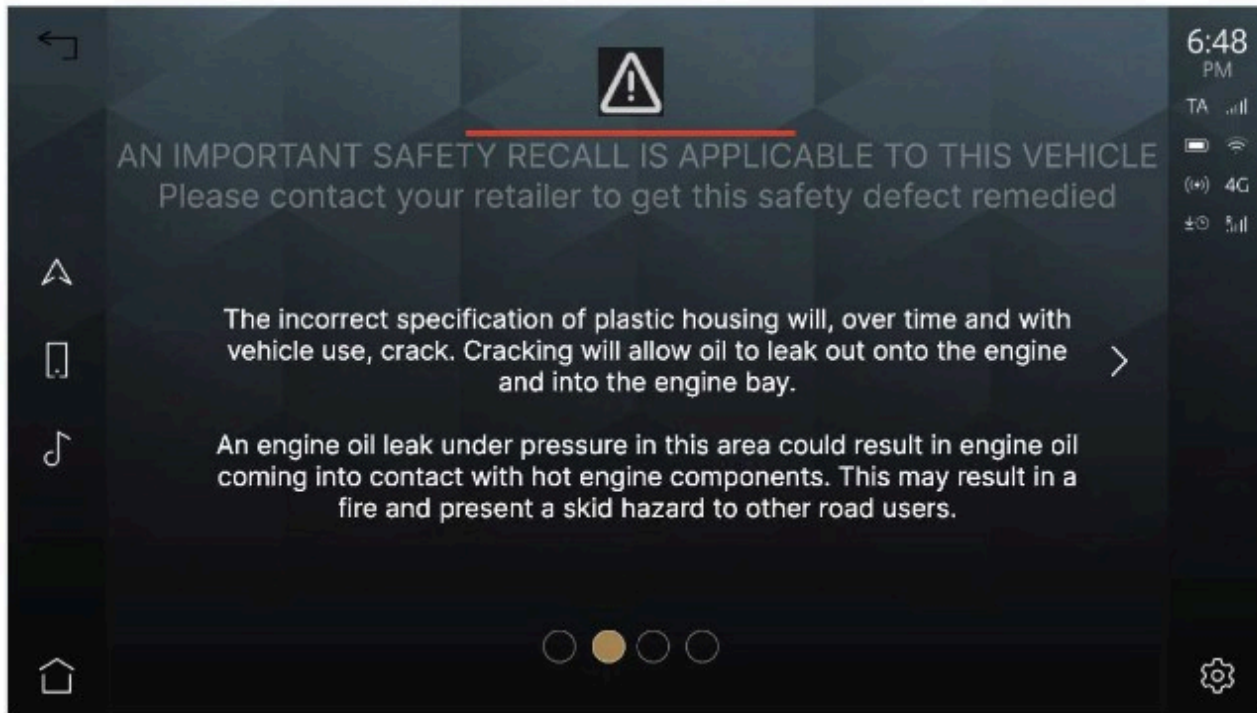
E373157

Screen text may vary between markets but the core messaging and screen format will be consistent on all vehicles.

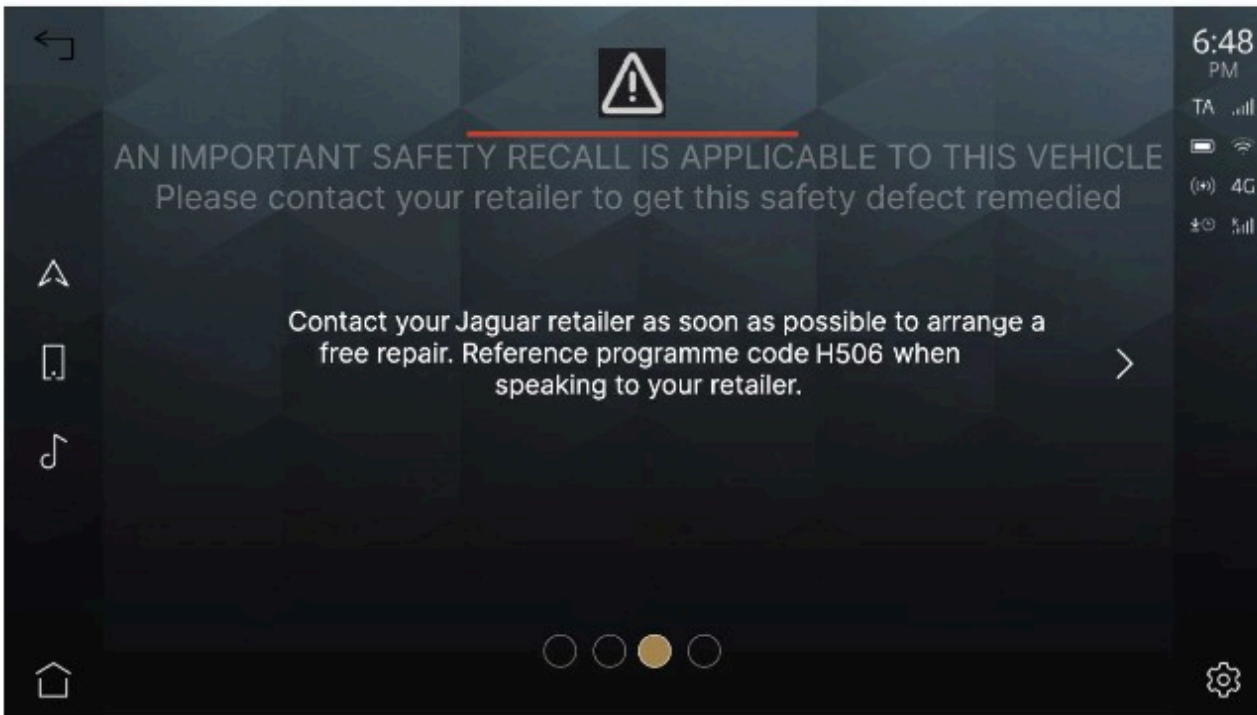
E373158

Screen text may vary between markets but the core messaging and screen format will be consistent on all vehicles.

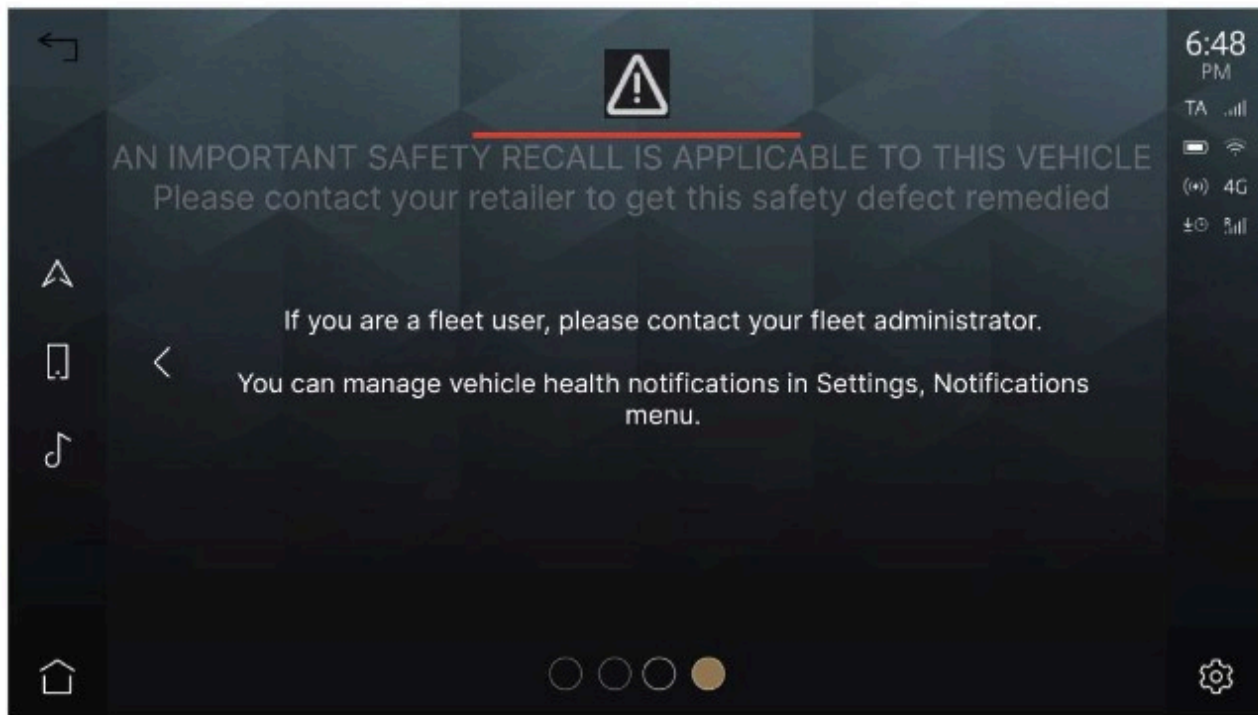
E373159

Screen text may vary between markets but the core messaging and screen format will be consistent on all vehicles.
