# SAFETY RECALL

Volvo Trucks North America

Date	Number	Release	Page
07. 2024	RVXX2405	01	1 (5)

## Auxiliary Axle Tie Rod Assembly VN, VHD

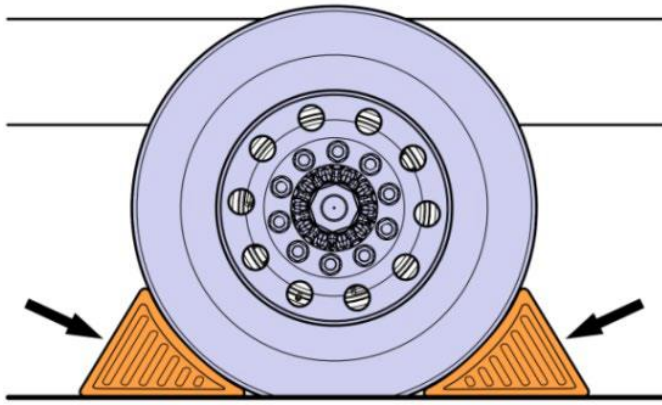
5. Hendrickson Compositite EXS20 lift axle suspension systems need to be inspected by looking for a stamped ID code on the tie rod. Please review the table below for the part numbers and date codes associated. If the tie rod does not have either of the suspect dates, return truck to service and file accordingly.

If ID code **101\_24** or **130\_24** is present, proceed with tie rod replacement.
