SAFETY RECALL

Mack Trucks Inc.
Greensboro, NC USA

Date	Number	Release	Page
07.2024	SC0468	01	1(5)

Auxiliary Axle Tie Rod Assembly PN, GR, LR

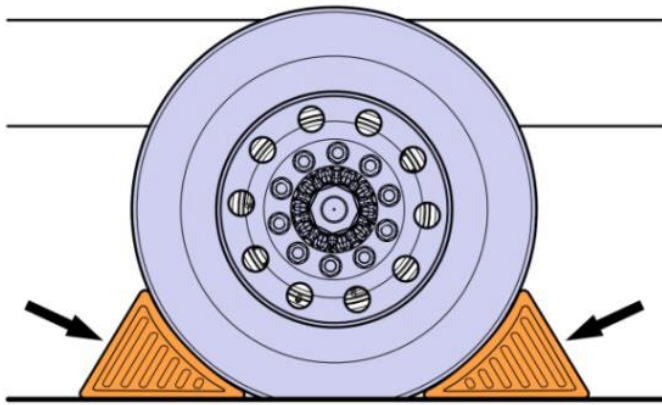
5. Hendrickson Compositite EXS20 lift axle suspension systems need to be inspected by looking for a stamped ID code on the tie rod. Please review the table below for the part numbers and date codes associated. If the tie rod does not have either of the suspect dates, return truck to service and file accordingly.

If ID code **101_24** or **130_24** is present, proceed with tie rod replacement.
