SIB 65 18 24

2024-08-26

RECALL 24V-513: Check Drivers Air Bag (Conversion PSDI-5)

This Service Information Bulletin (Revision #2) replaces SI B65 18 24 **dated August 2024**.

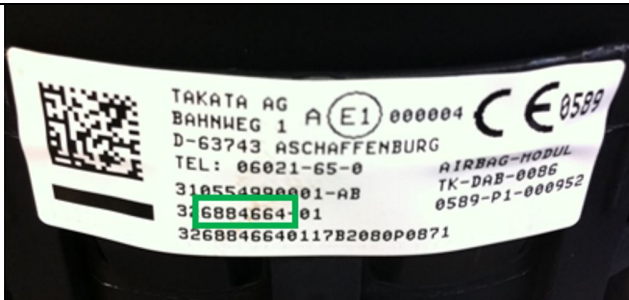
This is an E83 Sport air bag and may have been swapped into different vehicles.

If one of the above Sport steering wheels is installed, then:

1-Please record exterior cosmetic condition of air bag/steering wheel assembly on the Repair Order prior to any repair. Take pictures of any existing cosmetic damage.

2-Remove air bag to check parts label. Unless the air bag is either part number 6884664 or 6884672 (E8x, E9x) **OR** 6884661 or 6884669 (E83) then it must be replaced as per **REP 32 34 030** - Removing and installing/ replacing air bag unit (sport steering wheel)
