SIB 11 07 24

RECALL 24V-608: WATER PUMP ELECTRICAL CONNECTOR – RETROFIT SPLASH PROTECTION CAP

2026-01-16

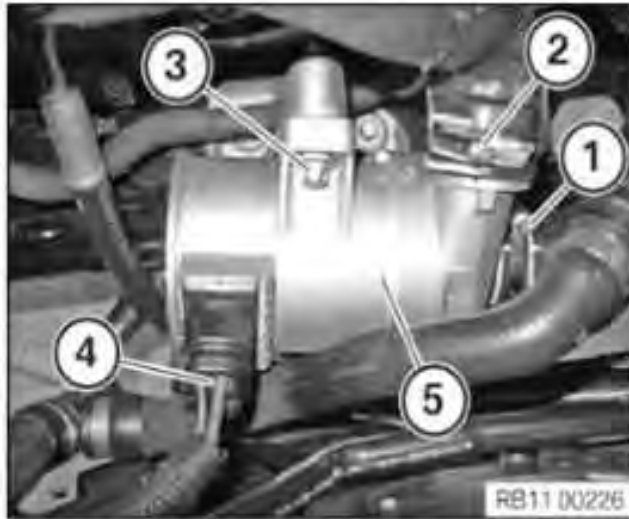
- Unlock connector (4) on the coolant pump (5) and pull it off
- Then remove any clips and clamps from the wiring harness and connector of the coolant pump, and guide it out upwards (engine compartment)
- If necessary, check the connector and connector connection on the coolant pump with an endoscope looking for moisture ingress (wet with water or oily) and any existing corrosion
- REQUIRED** - Use the WarrantyApp to provide picture documentation of your findings for all recall repairs, see below.
