SIB 11 07 24

RECALL 24V-608: WATER PUMP ELECTRICAL CONNECTOR – RETROFIT SPLASH PROTECTION CAP

2026-04-17

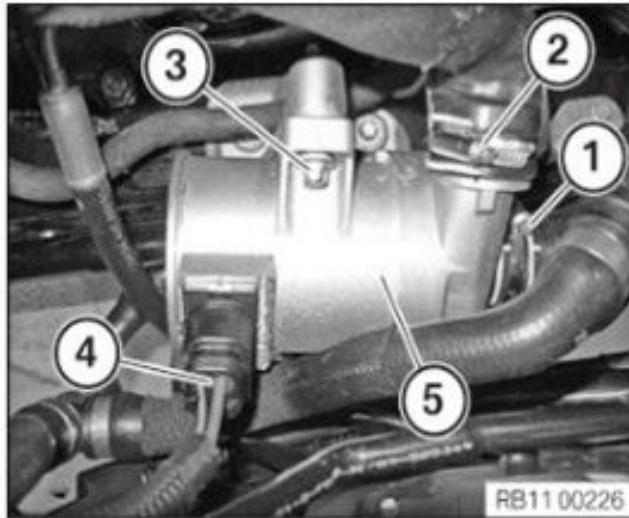
- Unlock connector (4) on the coolant pump (5) and pull it off
- Then remove any clips and clamps from the wiring harness and connector of the coolant pump, and guide it out upwards (engine compartment)
- If necessary, check the connector and connector connection on the coolant pump with an endoscope looking for moisture ingress (wet with water or oily) and any existing corrosion
- REQUIRED** - Use the WarrantyApp to provide picture documentation of your findings for all recall repairs, see below.
