Safety Recall 6824H – 2024 CX-30, Mazda3 and 2025 CX-50 – Forward Sensing Camera (FSC) Concern.

**SECTION A: VEHICLE INSPECTION PROCEDURE – AND PREPERATION FOR REPAIR**

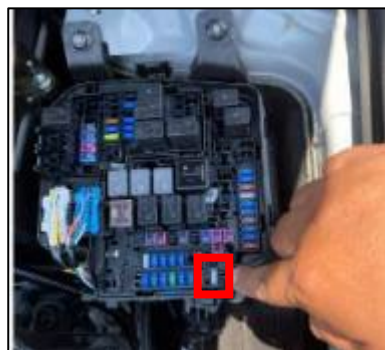
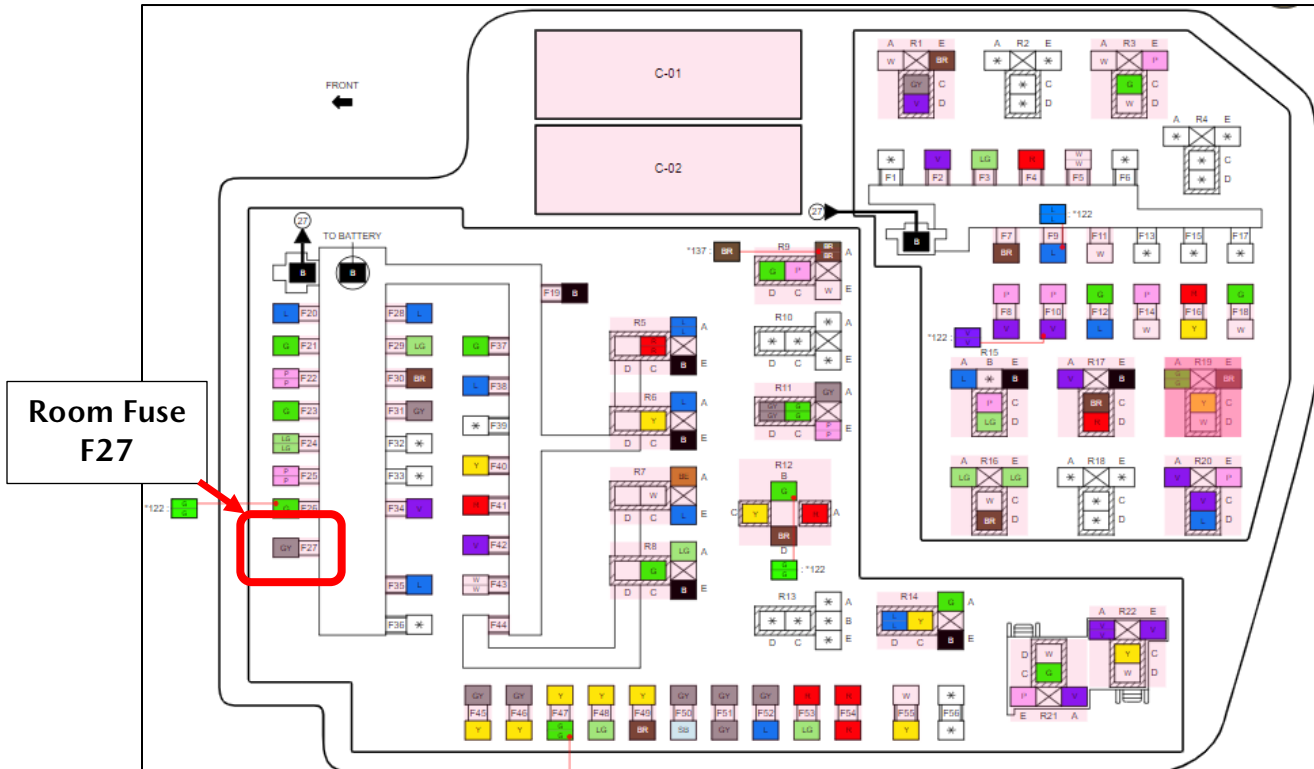
Mazda3, CX-30 & CX-50 Fuse location (F27)

- Confirm the 25A Room fuse has been installed. If not, install it.

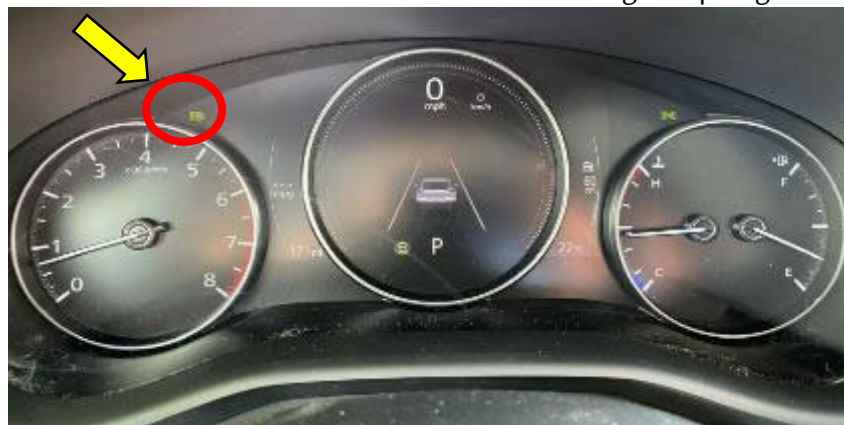
- a. Make sure the vehicle is securely on the lift and people are cleared from the vehicle. The vehicle will be accelerated while in the air to a speed of 10 MPH /16 KMH but no more than 15 MPH/24 KMH.
- b. Confirm the HIGH BEAM CONTROL indicator lights up in green.
