Safety Recall

Code: 57J9

Subject Document History	Door Handles																			
	Date	Summary																		
	12/19/2024	Original publication																		
Affected Vehicles

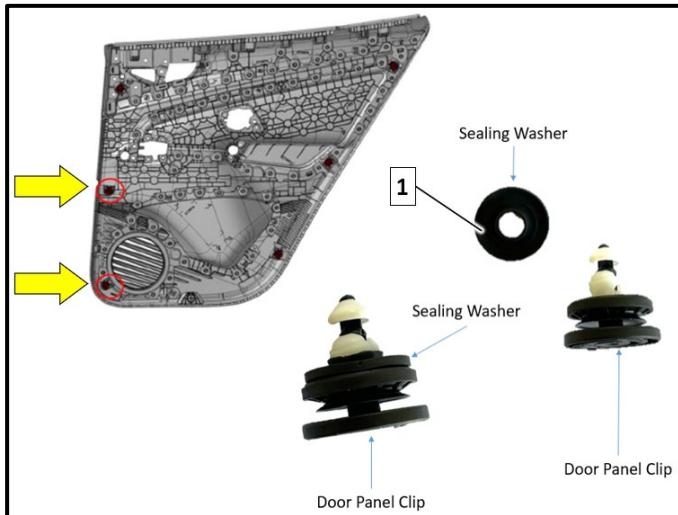
Criteria 02 vehicles only:

⚠ CAUTION

Risk of water leak!

- The door panel clips in the areas shown <arrows> include an additional sealing washer <1>.
- Ensure the sealing washer is not discarded and ensure it remains on the door panel clip.
- If the door panel clip is replaced, the sealing washer <1> must be transferred to the new clip.
- If the washer is not present on the old clip, check if the seal is stuck to the door and transfer it to the new clip as necessary.
- If the sealing washer is missing and must be replaced, the only way to obtain one is to order CLIP part number WHT-009-448 and remove the washer from the new clip.

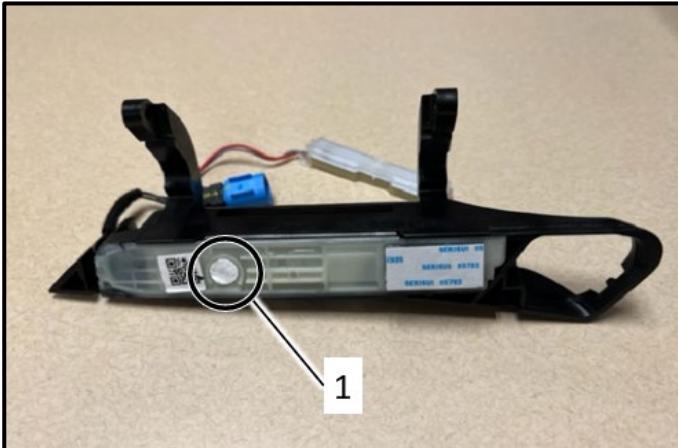
Old door handle:

- To ensure the new and old door handles are not mixed up, mark the door handles accordingly.
- The old door handles have the membrane located on the front of the door handle in the area indicated <1>.
- The new door handles do not have a membrane or an opening in the area indicated <2>.
- The new door handle can also be identified by the presence of the membrane on the back of the assembly in the area indicated <3>.

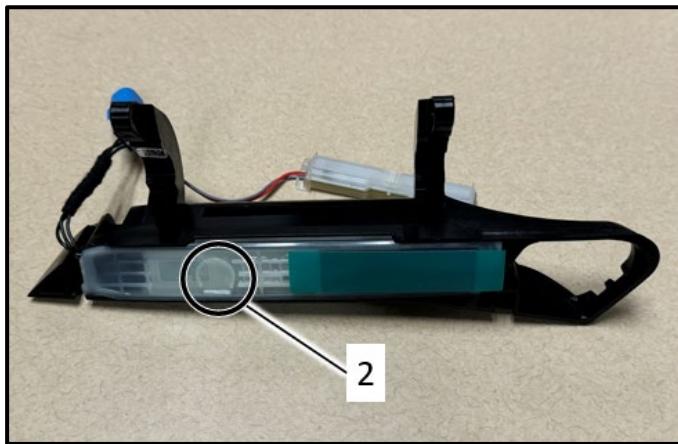
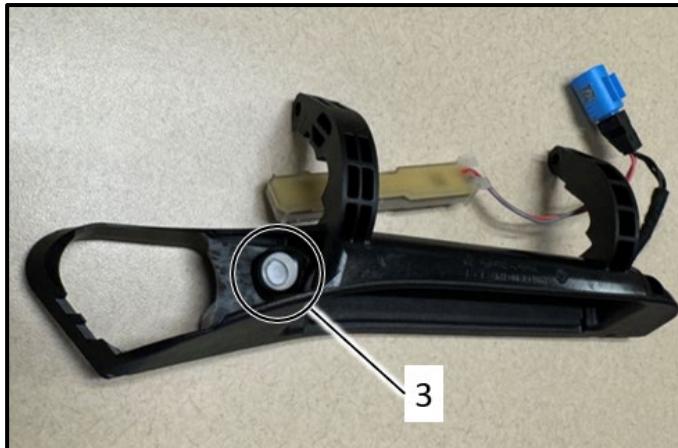
New door handle:

Do not touch or allow anything to contact the vapor membrane <1> located on the back of the new door handles.

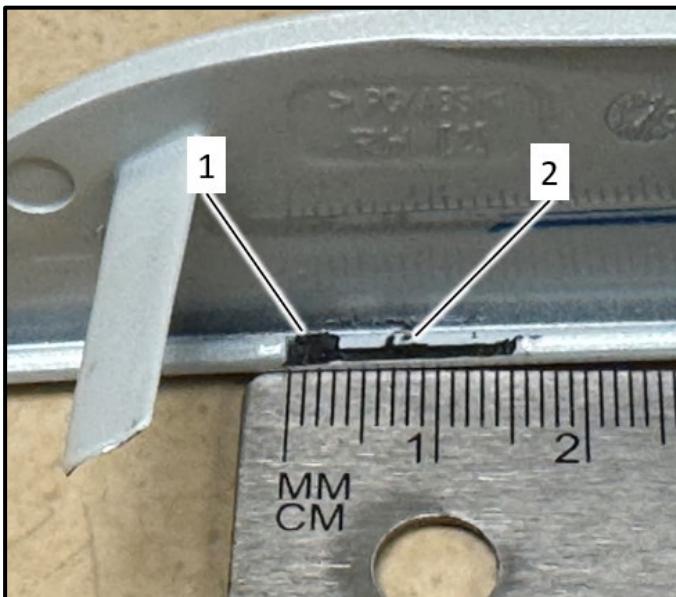
The cover modifications must not be visible when the cover is installed. The depth of the modification <1> must not be so deep that the exterior of the cover <2> is damaged. Only remove enough material so that retaining tabs are flush with the bottom of the cover.

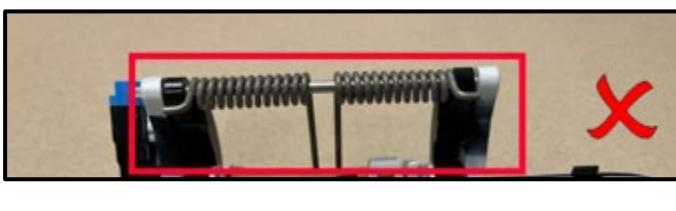
- Incorrect spring installation = Spring tabs facing the front of the door handle.

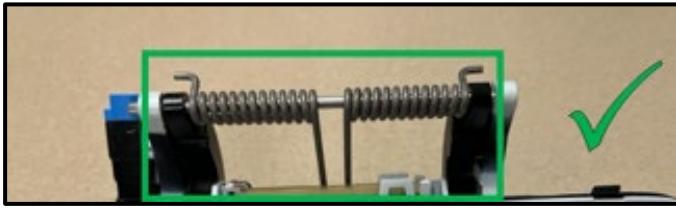
- Correct spring position = Spring tabs facing the back of the door handle.

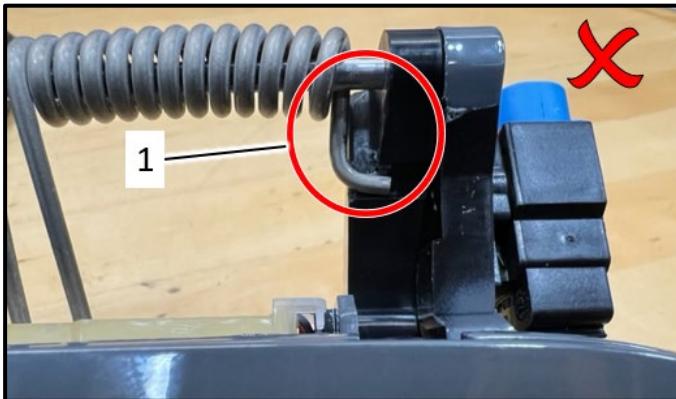
- Spring tab <1> that is not fully engaged.

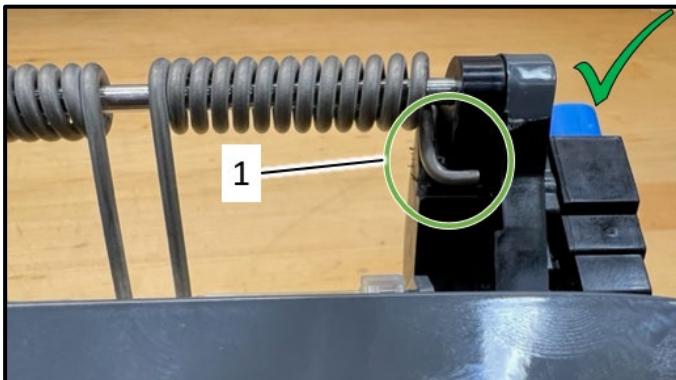
- Spring tab <1> that is fully engaged.
