SIB 34 04 24

2024-10-03

**RECALL 24V-697: INTEGRATED BRAKE SERVOMOTOR**

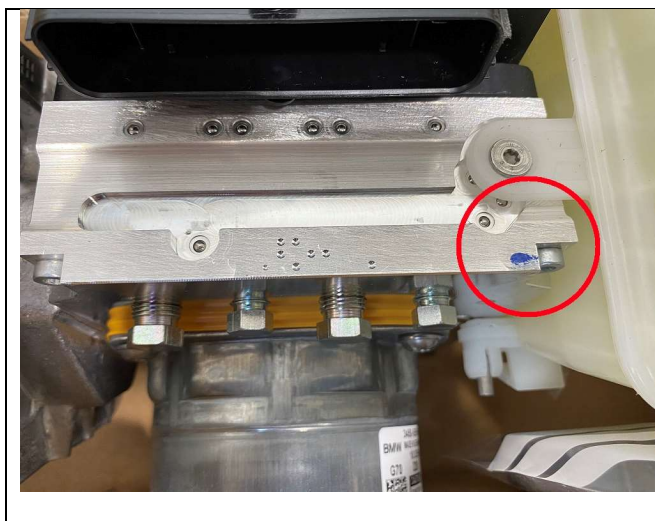
6. Verify the blue dot is located on the part number label as shown in the photo.

**Note:** Photo shown for location of blue dot on the parts label and does not indicate the part number for all models

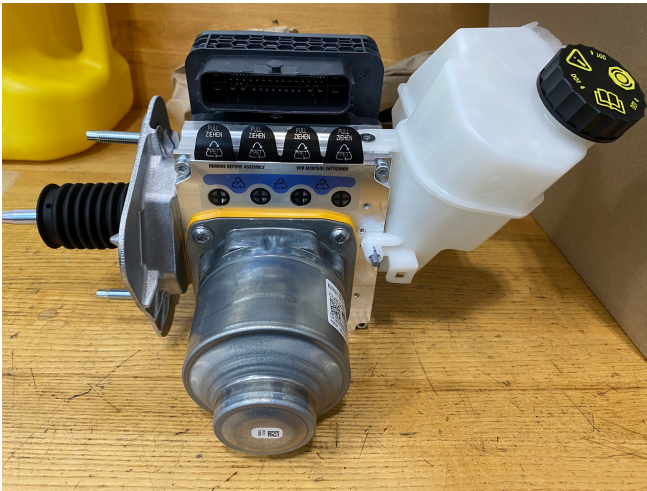
Part number:  
5B5F8F1

“Wet” IB pre-filled: Brake fluid reservoir is filled (arrow) and the four brake fluid line ports are plugged with bolts (circled).

If you have received a “wet” unit, follow the repair per the Attachment 1, “Service Function and replace Wet IB pre-filled”.
