SIB 34 07 24

2024-11-19

RECALL 24V-739: INTEGRATED BRAKE SYSTEM (IB)

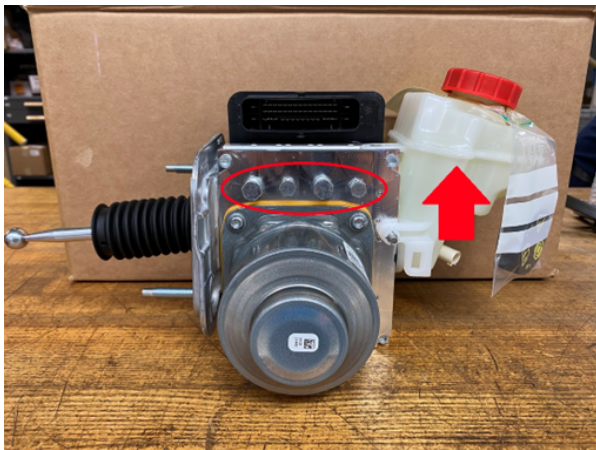
“Wet” IB pre-filled: Brake fluid reservoir is filled (arrow) and brake fluid line ports are plugged with bolts (circled).

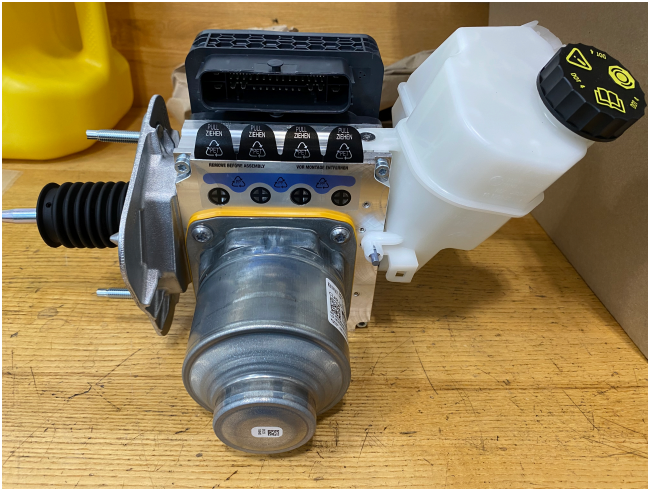
“Dry” IB unfilled: Brake fluid reservoir is empty; brake fluid line ports are sealed with labels.

3. Return the part if the Blue-Dot is not found on the label or unit
