SIB 34 07 24

2025-03-04

**RECALL 24V-739: INTEGRATED BRAKE SYSTEM (IB)**

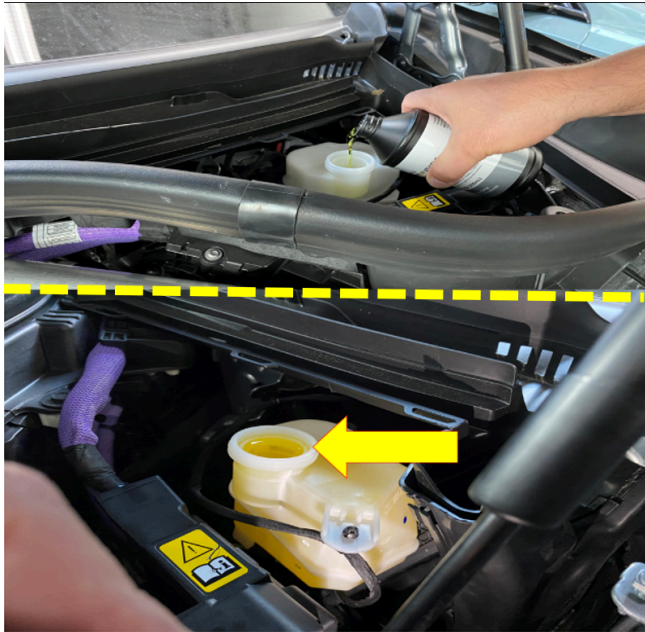
If you have received a “**wet**” unit, follow the REP34 51 601 Replacing hydraulic unit

If you have received a “**dry**” unit, follow the REP 34 51 602 Replacing the hydraulic unit (not filled).
