## IMPORTANT SAFETY RECALL

**NHTSA Safety Recall 24V-742**

**TO: Winnebago Motorhome Dealers**  
**SUBJECT: Campaign # 190 – Seat Belt Retractor**

# View/Navion Seat Belt Retractor Rework – Recall #190:

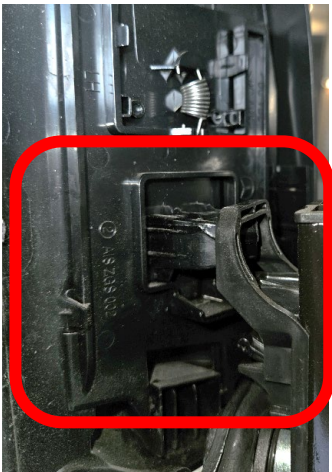
Image 1

1. With the B Pillar cover pulled away, inspect the retractor again. Ensure on the wingwall side that all screws that contacted the retractor are removed.

2. Reinstall the B Pillar cover.
  - a. Note:** When reinstalling the B Pillar cover, ensure that the tab on the B pillar cover is in alignment with the mating connection on the B pillar, See Image 1. Confirm alignment after reinstallation of the cover by actuating the seat belt height adjustment. See Image 2.
