# Safety Recall

## N242454440 Momentary Rear Wheel Lock-Up

**Release Date:** March 2025

**Revision:** 02

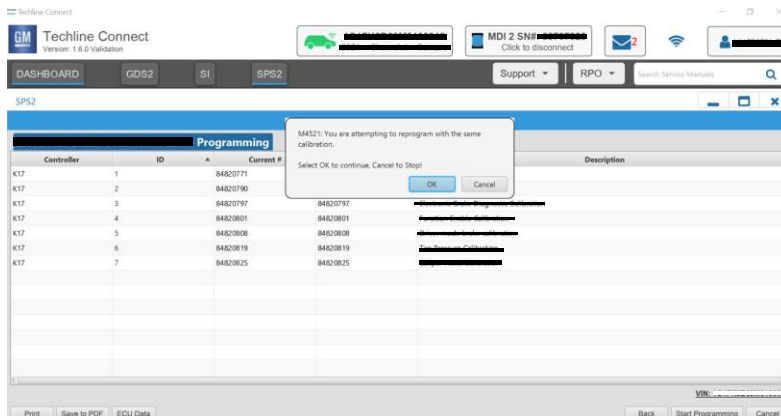
5644477

**Important:** Techline Connect screens shown above.

**Important:** If the same calibration/software warning is noted on the TLC Summary screen, select OK and follow screen instructions. After a successful programming event, the WCC is located in the Service Programming System dialogue box of the SPS Summary screen. No further action is required. Refer to the Warranty section of the bulletin.
