## Safety Recall – 2024 CX-90 Sudden increase in steering effort

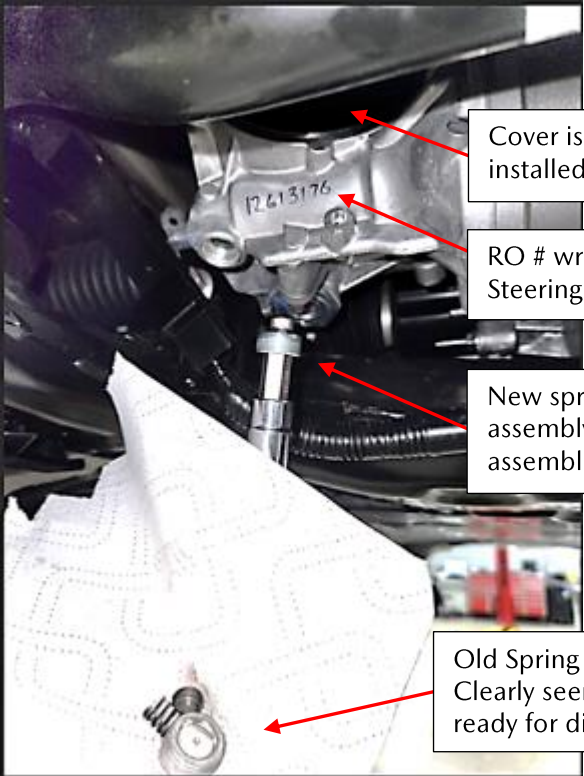
<p><b>PHOTO REQUIREMENT:</b></p> <p>Attach one photo to the warranty claim.</p> <p><b>NOTE:</b> Photo must show the RO# of the vehicle repaired.</p> <p>See photo example: Take a photo so that the new integrated cap, spring, end cap are ready to be installed, and old spring which will be discarded are all visible.</p> <p>Make sure the RO# written on the rack is present in the photo.</p>
