F1017 A

Creation Date: 05/16/2025
Revised Date: 06/06/2025
NHTSA # 25V-046
Transport Canada # 2025-040

Subject: Electric Vehicle Power Distribution Module

Inspection and Repair of the Electric Vehicle Distribution Module (EVDM) Connector Plate

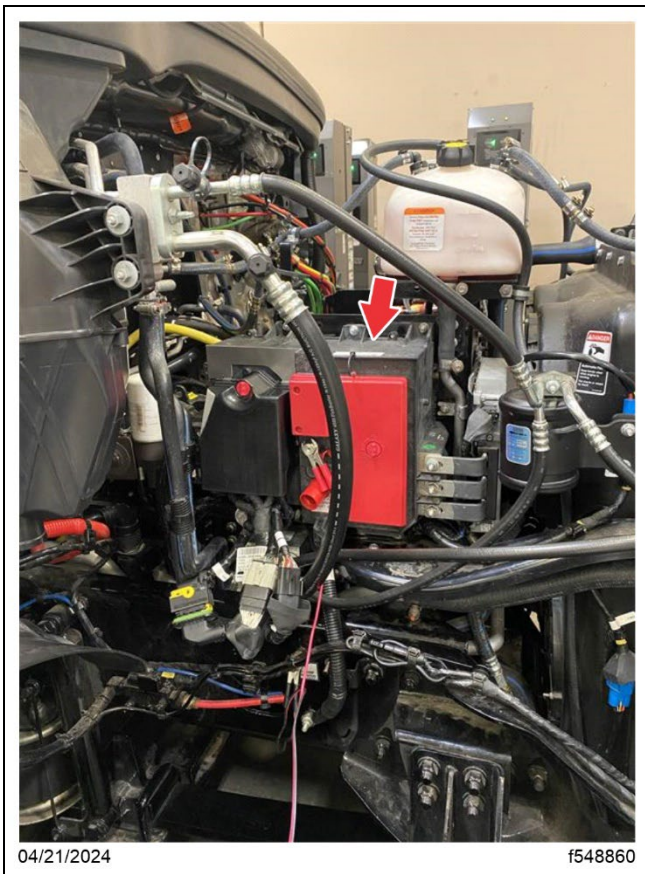
Fig. 1, EVDM on the Vehicle

4. Locate the sticker on top of the EVDM and check the serial number. Inspect if the clean date on the EVDM is on or after 10/07/2024 (20241007XX). See [Fig. 1](#) and [Fig. 2](#).
