Service Engineering Operations  
Customer Service Division

June 3, 2026

**SUBJECT: NEW VEHICLE DEMONSTRATION / DELIVERY HOLD**  
**Safety Recall 25S95 - Supplement #1**  
Certain 2023-2024 Model Year Transit Internal Combustion Engine (ICE) Vehicles  
Tire and Steering Shaft Bolt Replacement

# CERTAIN 2023-2024 MODEL YEAR TRANSIT INTERNAL COMBUSTION ENGINE (ICE) VEHICLES — TIRE AND STEERING SHAFT BOLT REPLACEMENT

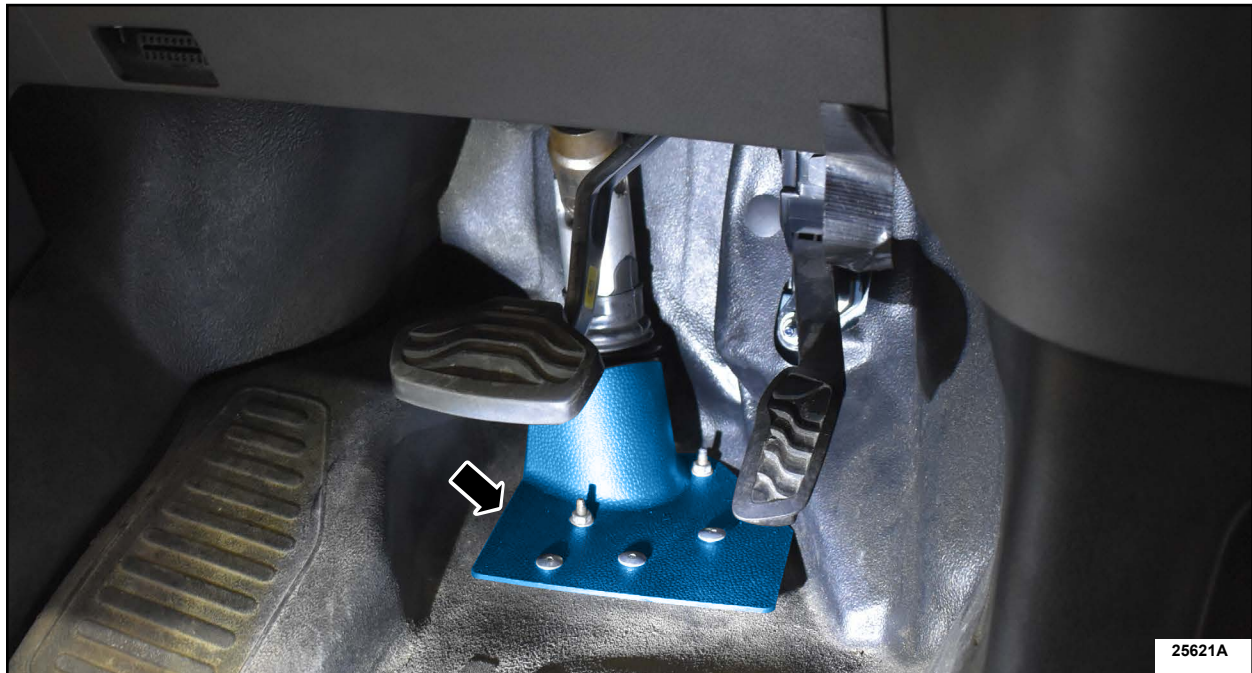
**FIGURE 17**

1. Inspect the steering column shaft protective shield on the driver side floor as shown in Figure 17. Is the steering column shaft protective shield shown in Figure 17 present?
